2024 ASSET MANAGEMENT PLAN

Lake of the Woods
PO Box 427
Rainy River, ON, P0W 1L0

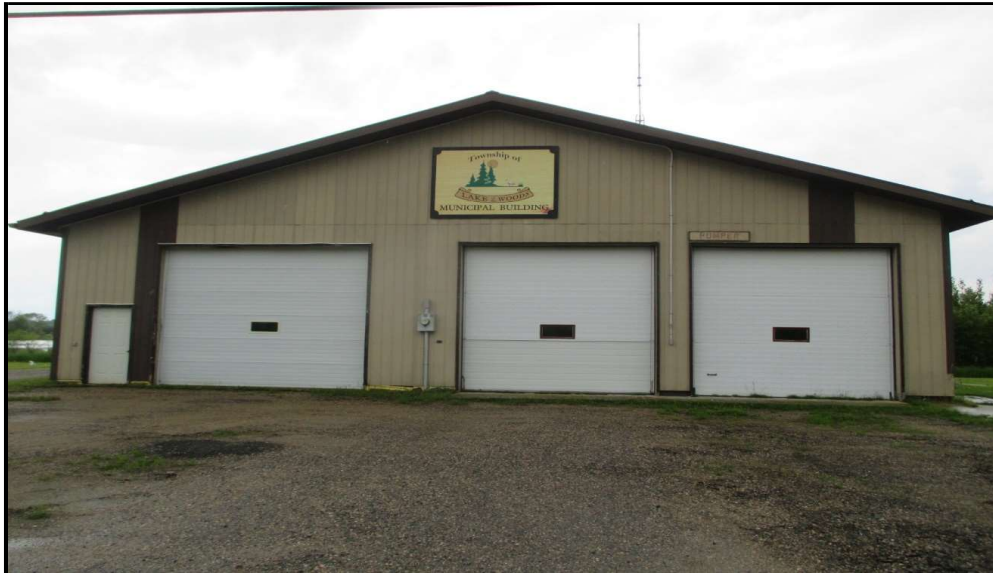
Photo No.:
 Description:
 The front elevation of the building
 Replace damaged o/h door trim

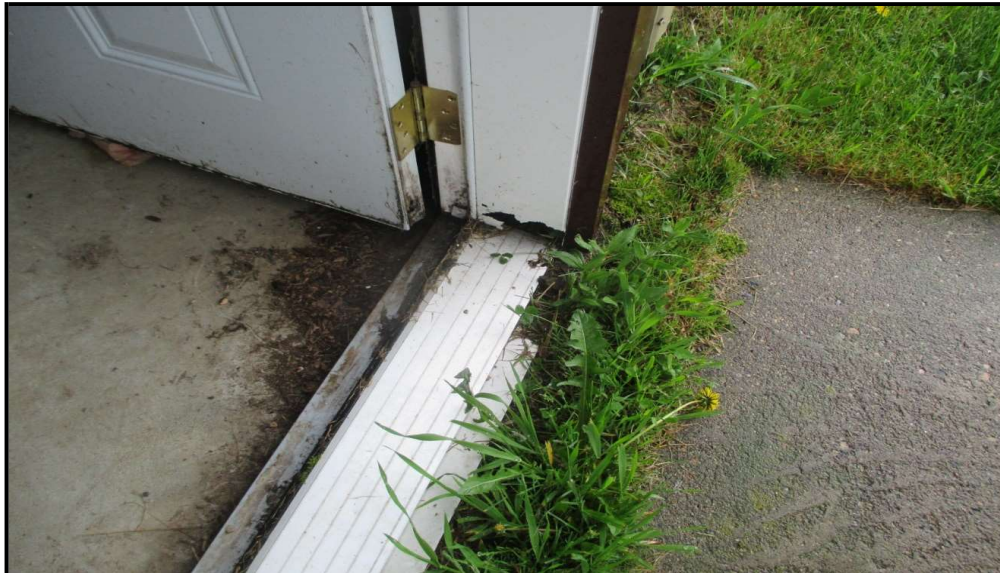
Photo No.:
 Description:
 Exterior view
 Replace broken man door frame

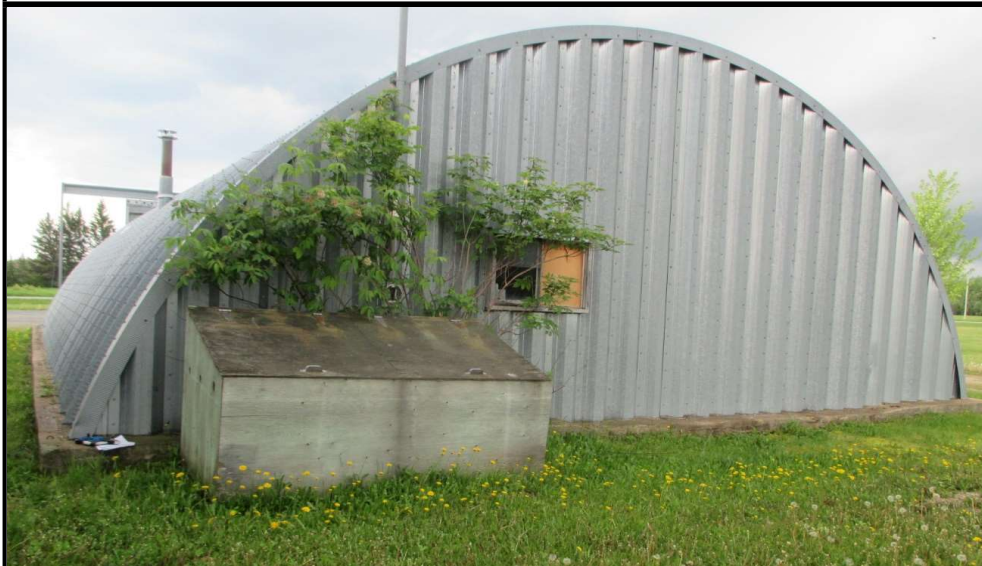
Photo No.:
 Description:
 Rear Elevation
 Replace window, Cut trees at
 the back of the building

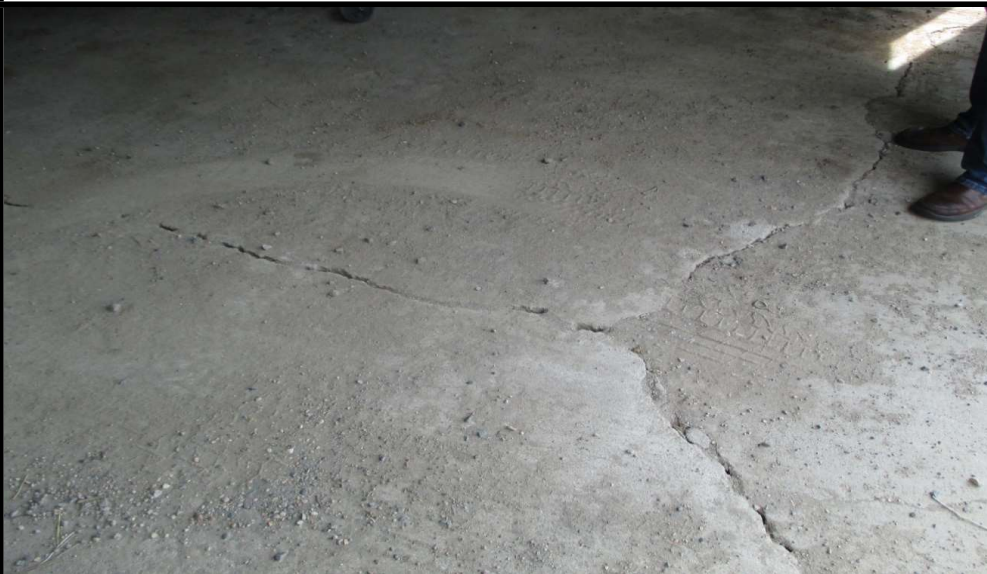
Photo No.:
 Description:
 Interior view
 Parge cracks in concrete floor

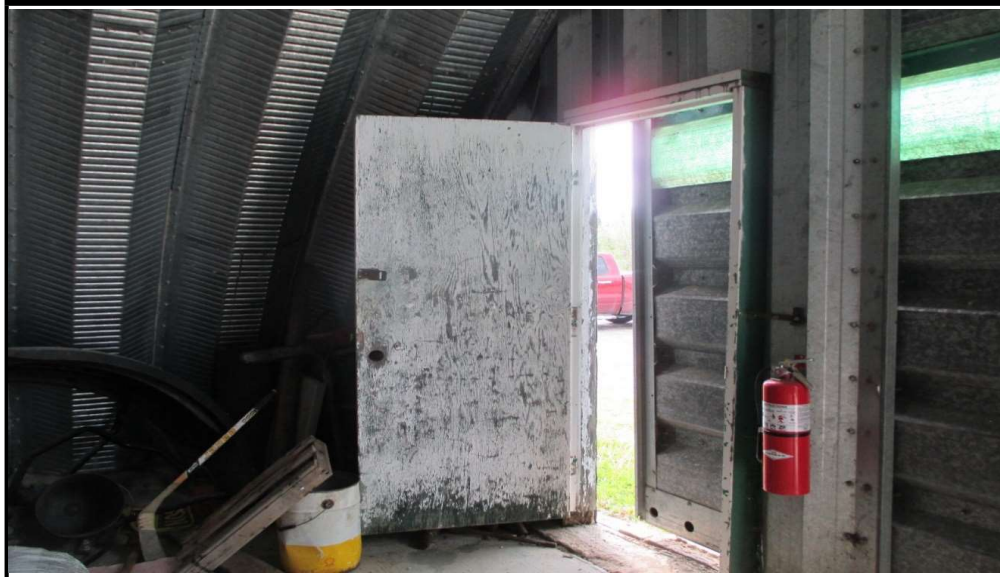
Photo No.:
 Description:
 Interior view
 Replace man door complete
 with lockset

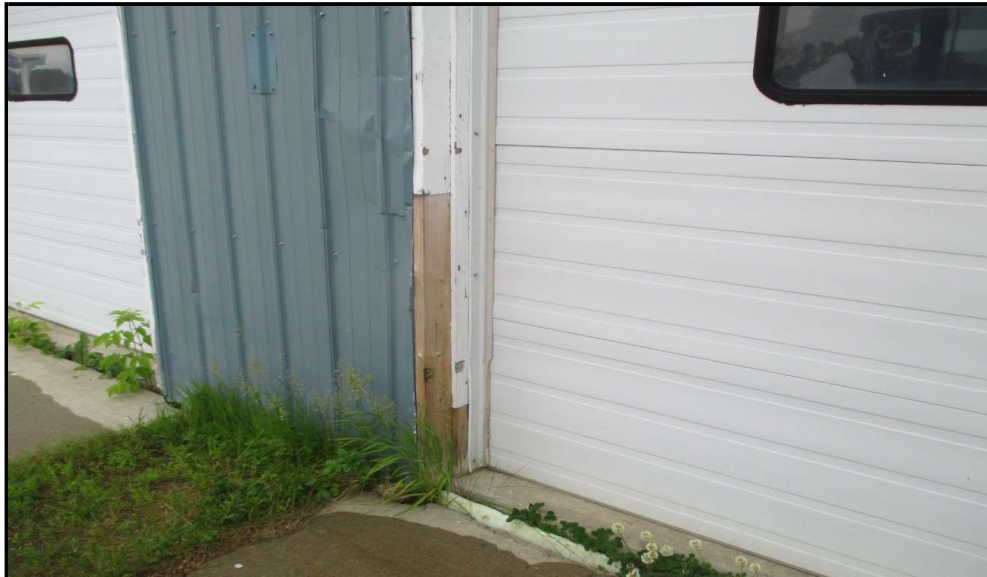
Photo No.:
 Description:
 Exterior view
 Replace damaged o/h door
 frame

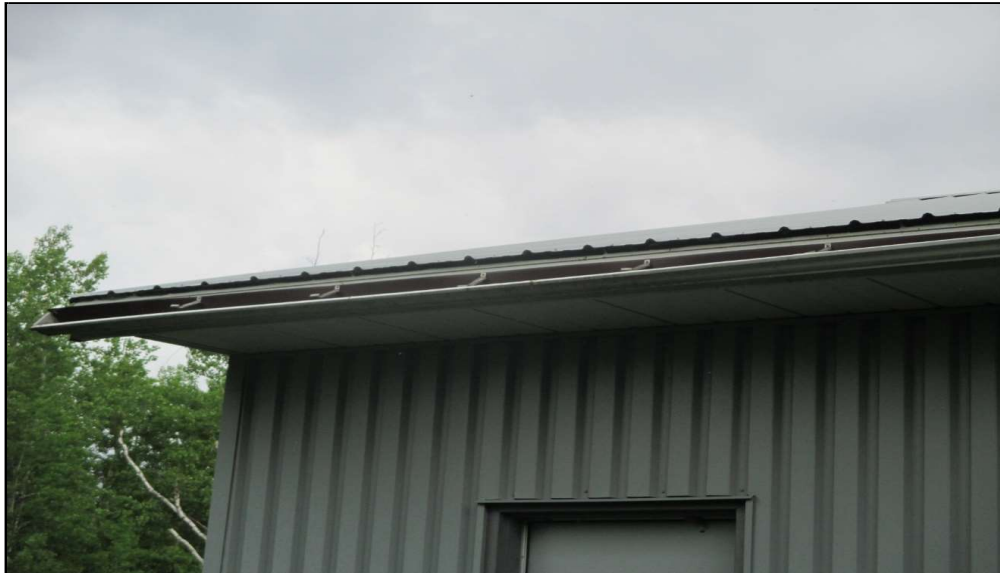
Photo No.:
 Description:
 Exterior view
 Repair bent eavestroughs

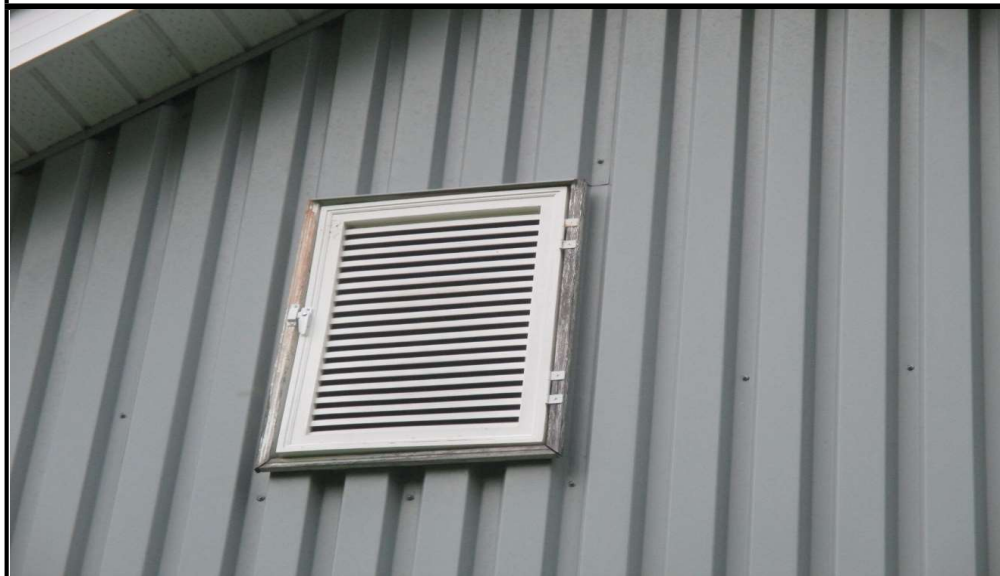
Photo No.:
 Description:
 Exterior view
 Repaint gable vent on back of
 the building

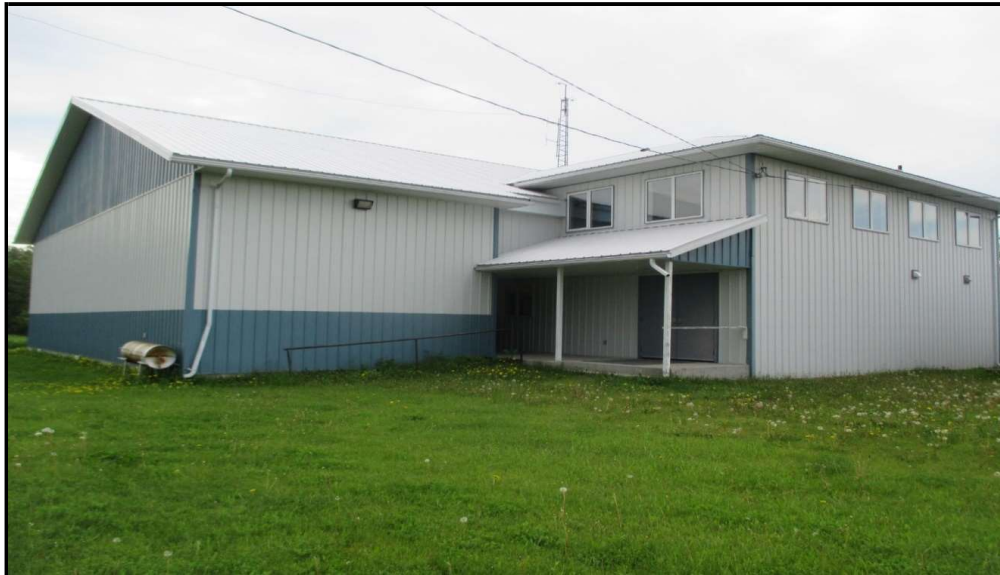
Photo No.:
 Description:
 Rear Elevation
 Replace handrails at rear door

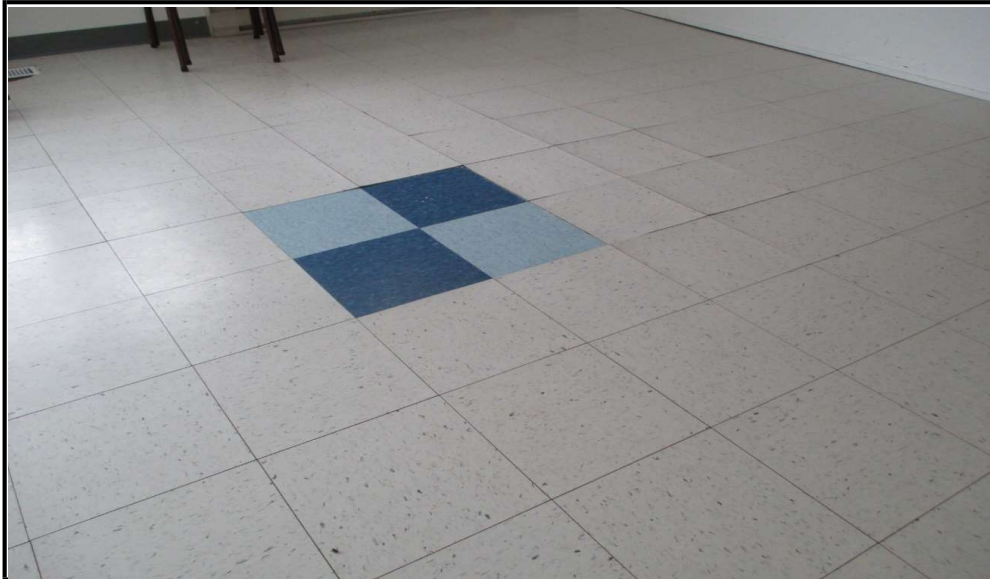
Photo No.:
Description:
 Interior view- second floor
 Replace lifting floor tiles in 2nd floor

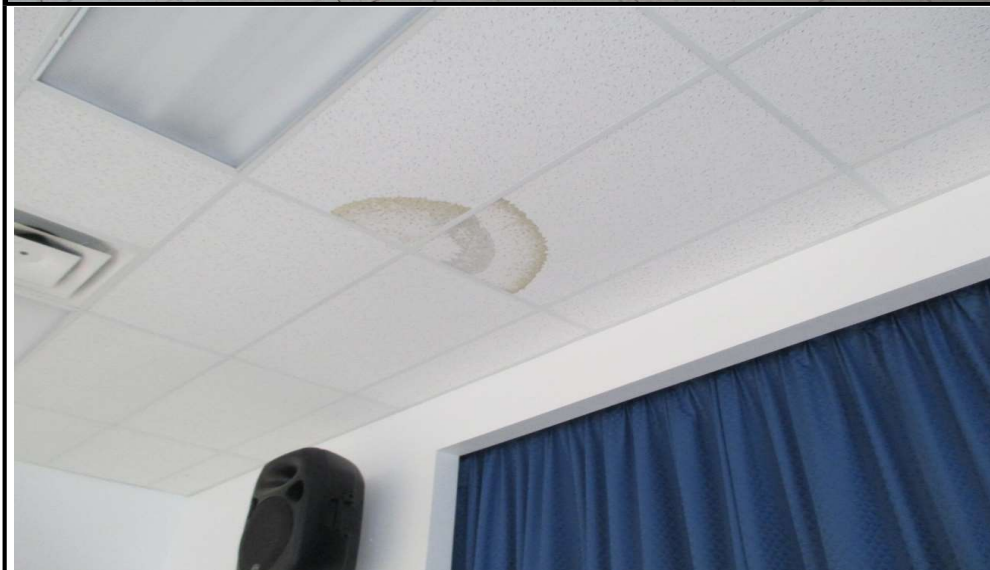
Photo No.:
Description:
 Interior view- second floor
 Replace water stained ceiling tiles by stage and investigate

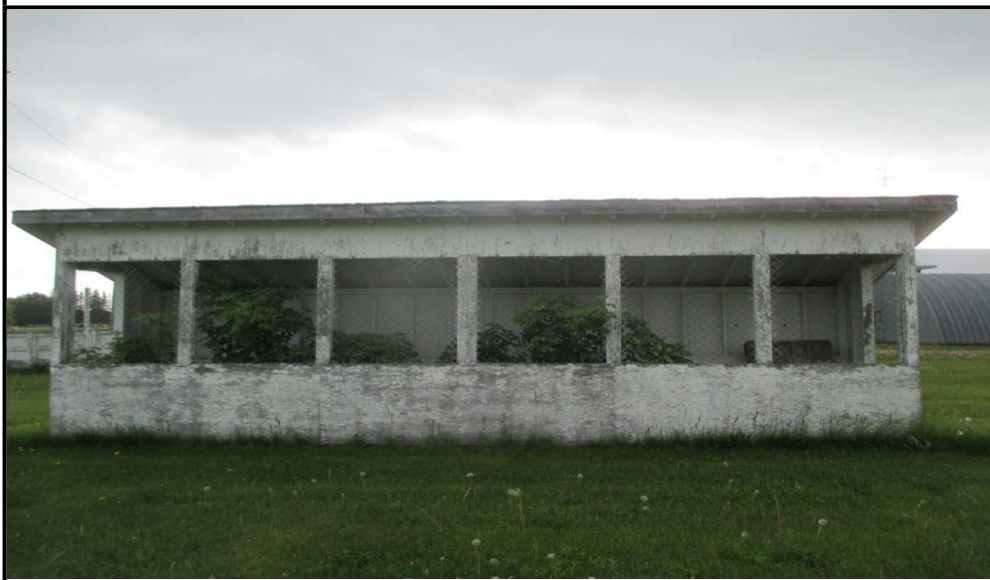
The view of Ball Diamond
Replace rotten fascia on
dugouts and repaint

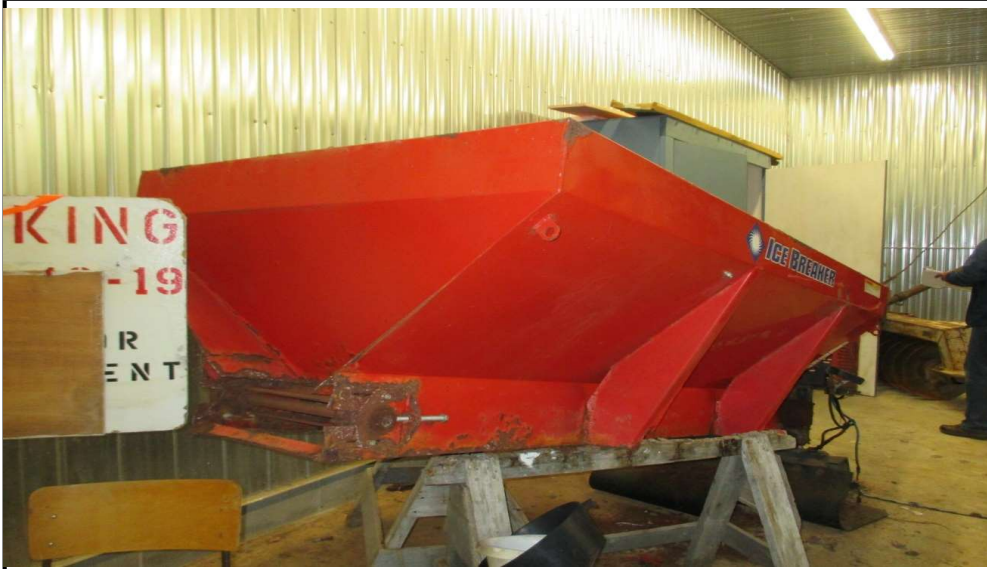
The view of the Sander
Sandblast & reapint rusting area

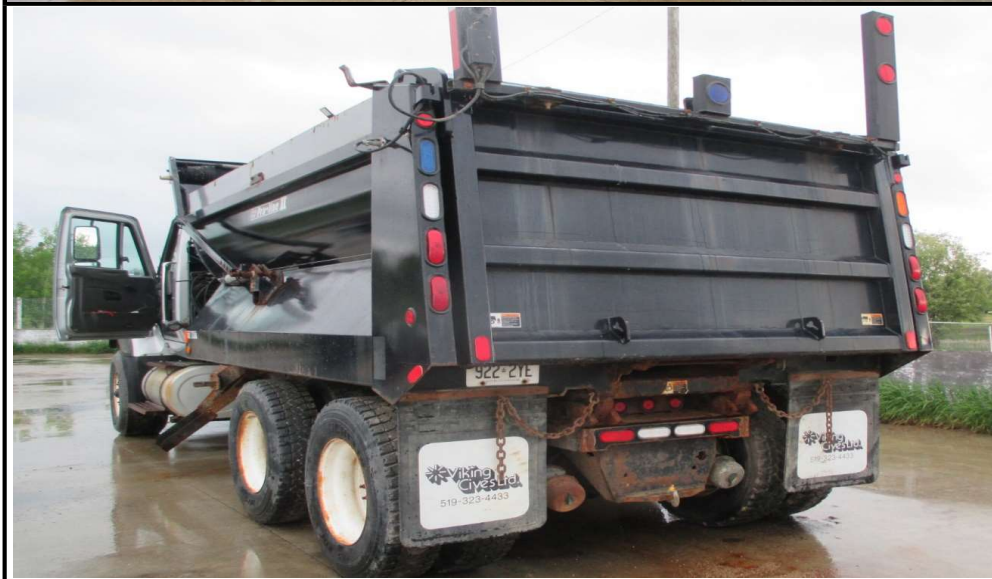
Exterior view
Repaint rusting side steps and
fuel tank

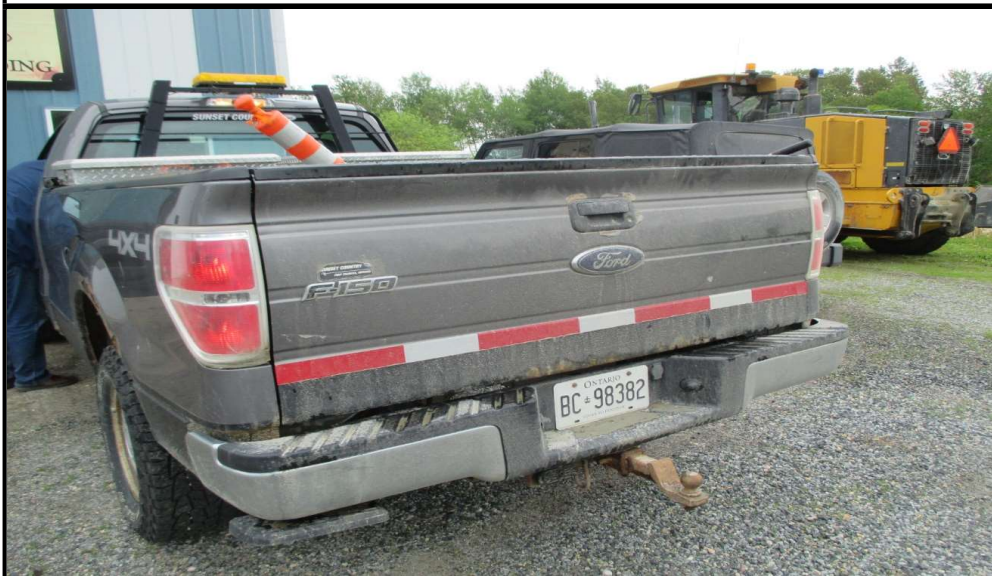
Exterior view
Minor body work required
(rusting)
