2024 ASSET MANAGEMENT PLAN

Lake of the Woods
PO Box 427
Rainy River, ON, P0W 1L0

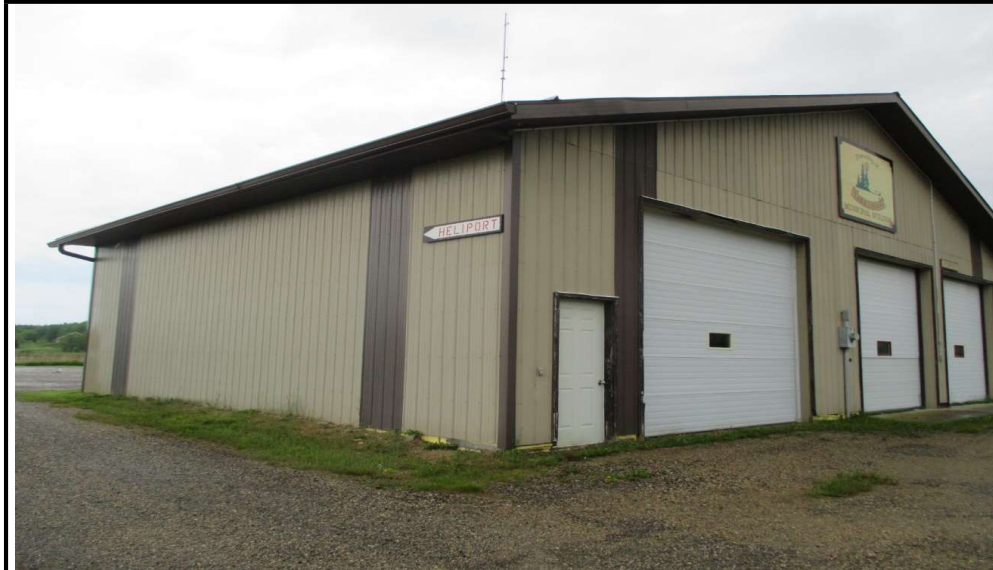
Photo No.:
 Description:
 The front elevation of the building
 Replace damaged o/h door trim

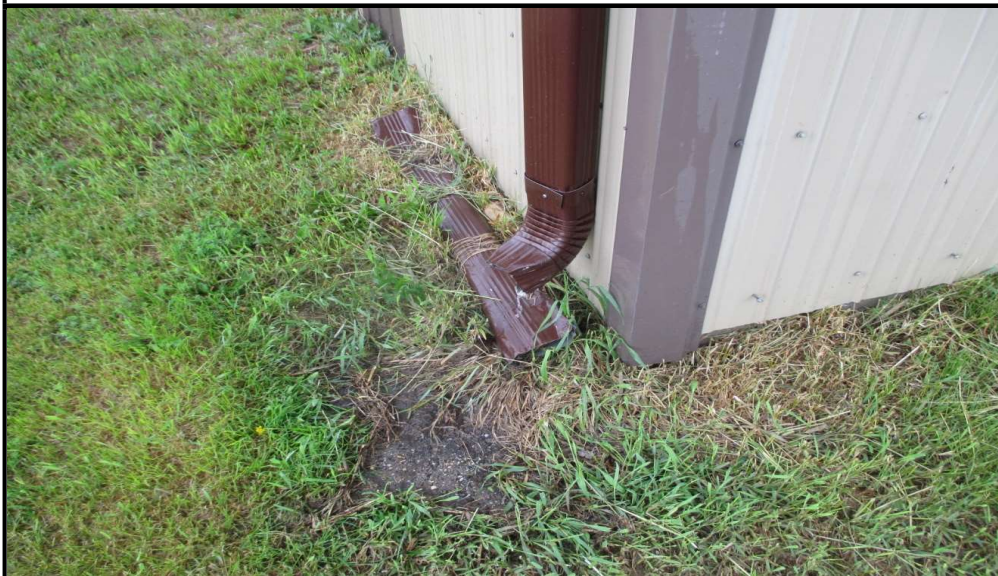
Photo No.:
 Description:
 Exterior view
 Provide splash pads at downspouts

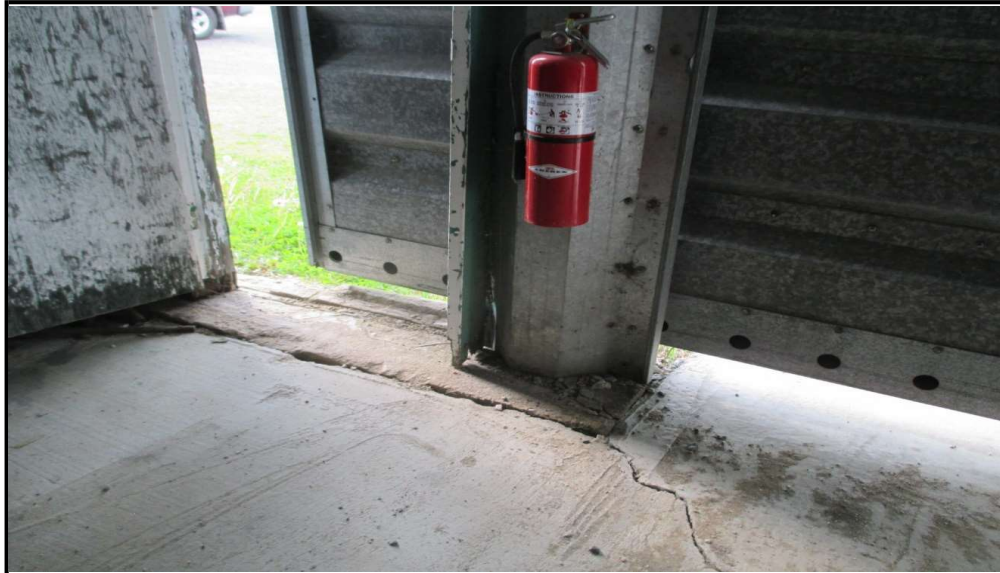
Photo No.:
 Description:
 Interior view
 Recertify Fire extinguisher

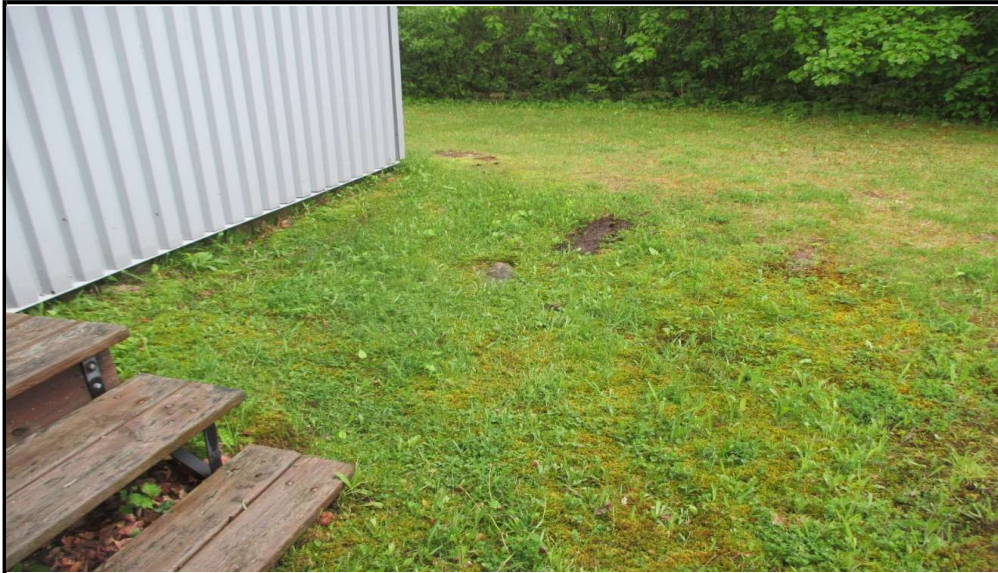
Photo No.:
 Description:
 View of the ground Grading
 required at the back of the
 building

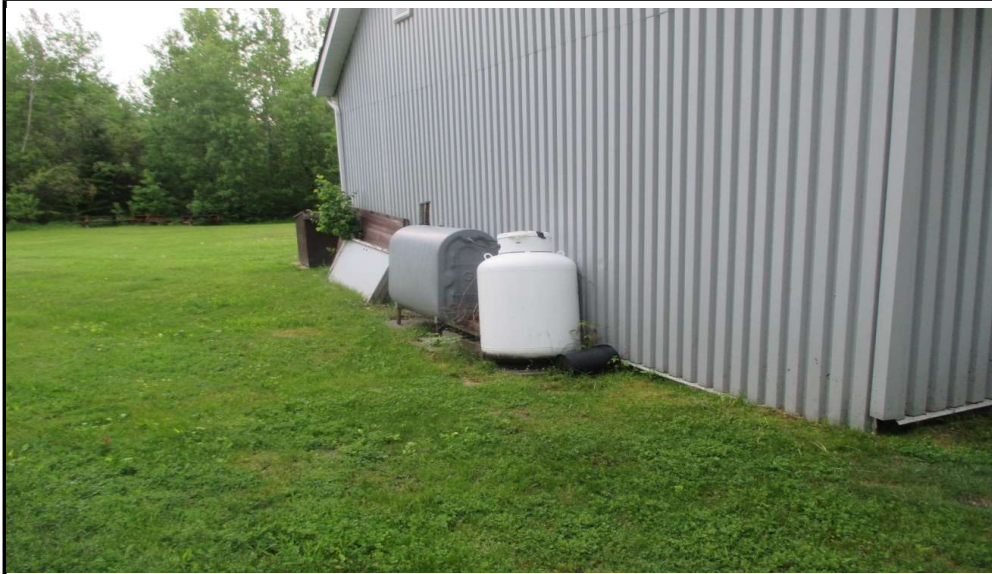
Photo No.:
 Description:
 Exterior view of the building
 Remove old fuel tank

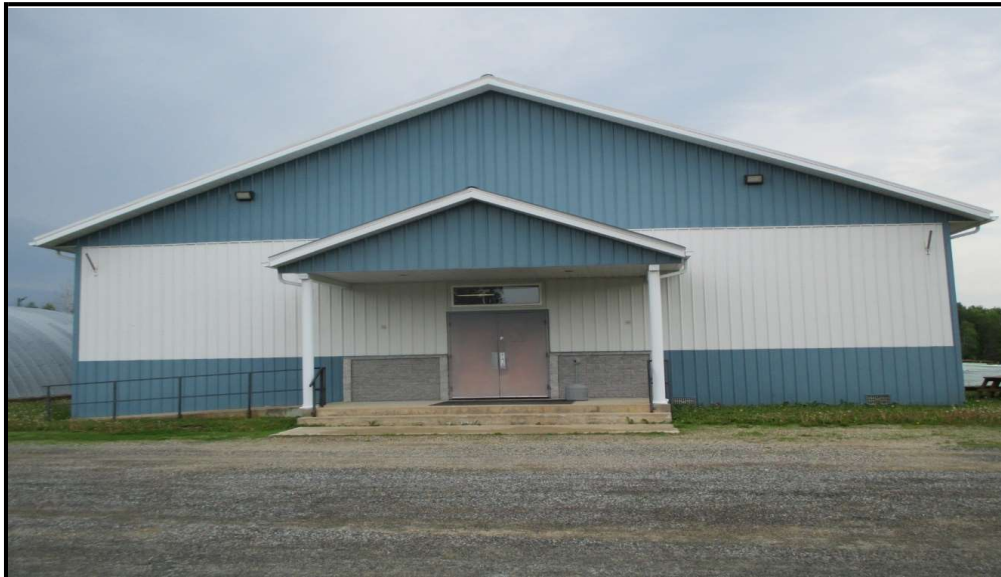
Photo No.:
 Description:
 Front elevation
 Repaint entrance doors

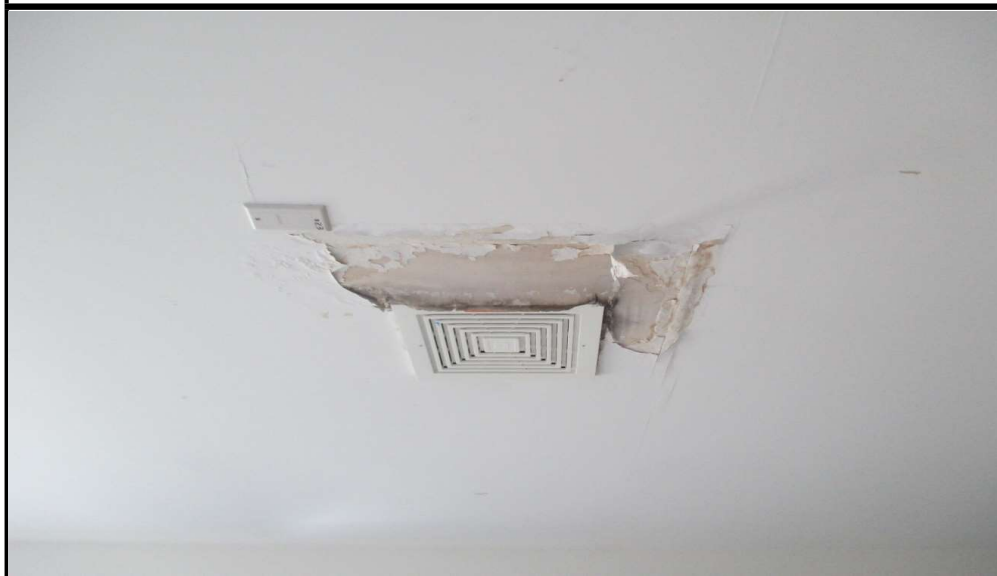
Photo No.:
 Description:
 Interior view- second floor
 Drywall touch ups required on
 2nd floor ceiling

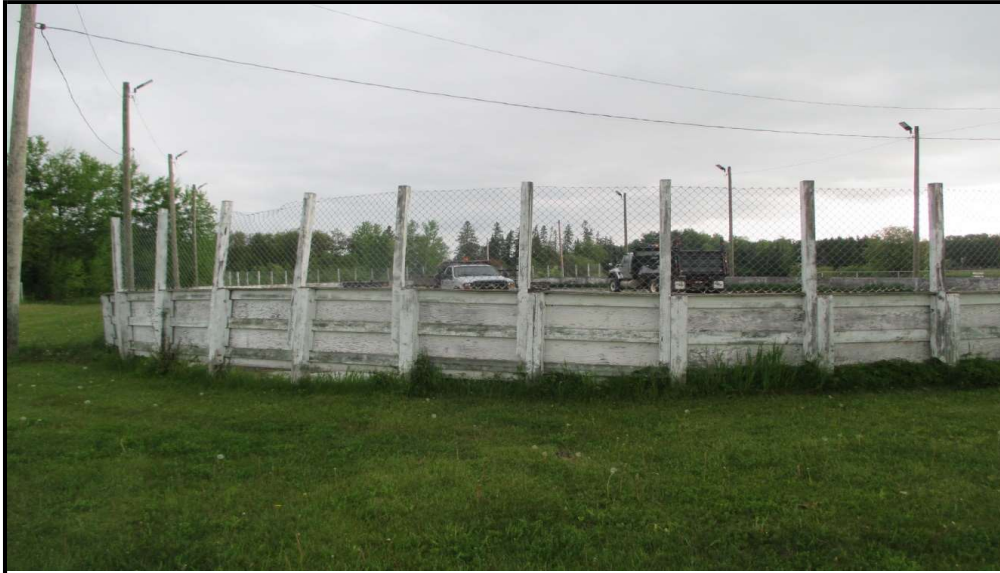
View of the Rink

Repaint rink boards

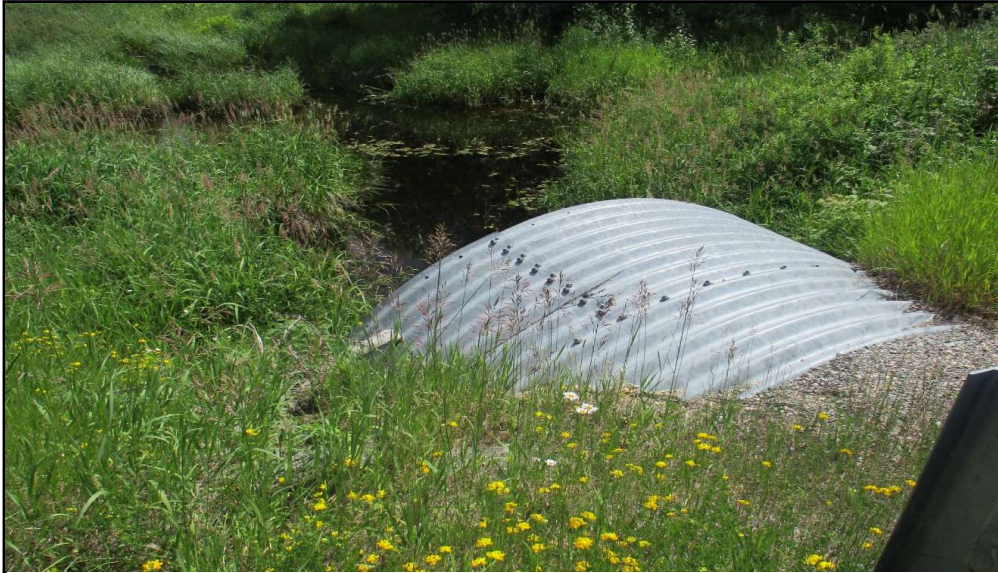
View of the culvert

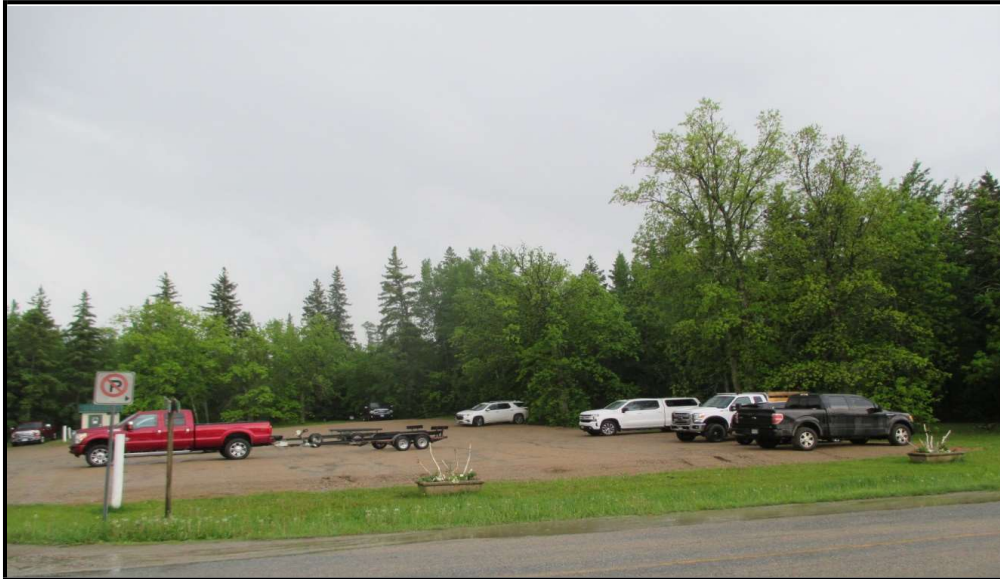
The view of Morson Dock
Parking Lot

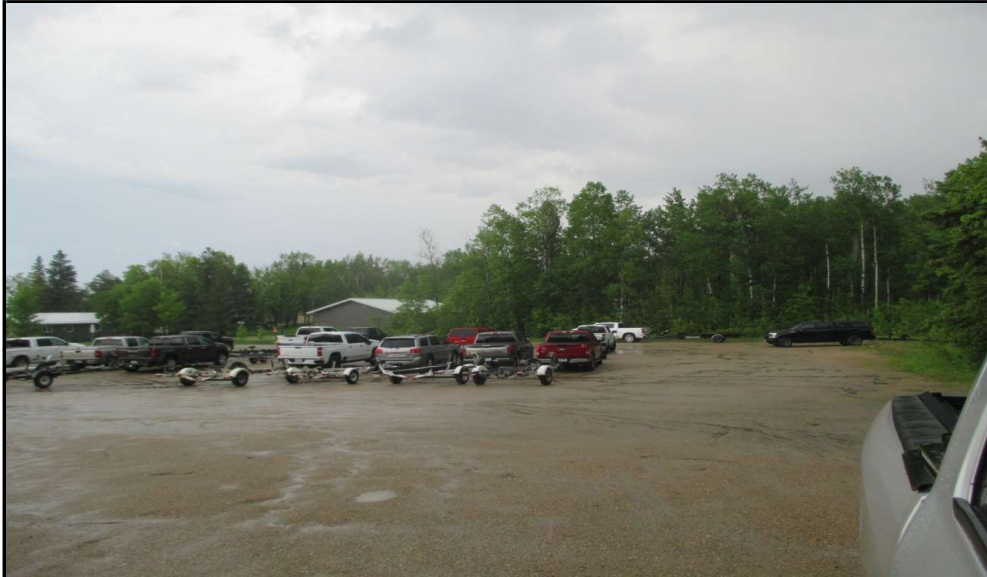
The view of Morson Dock
Parking Lot

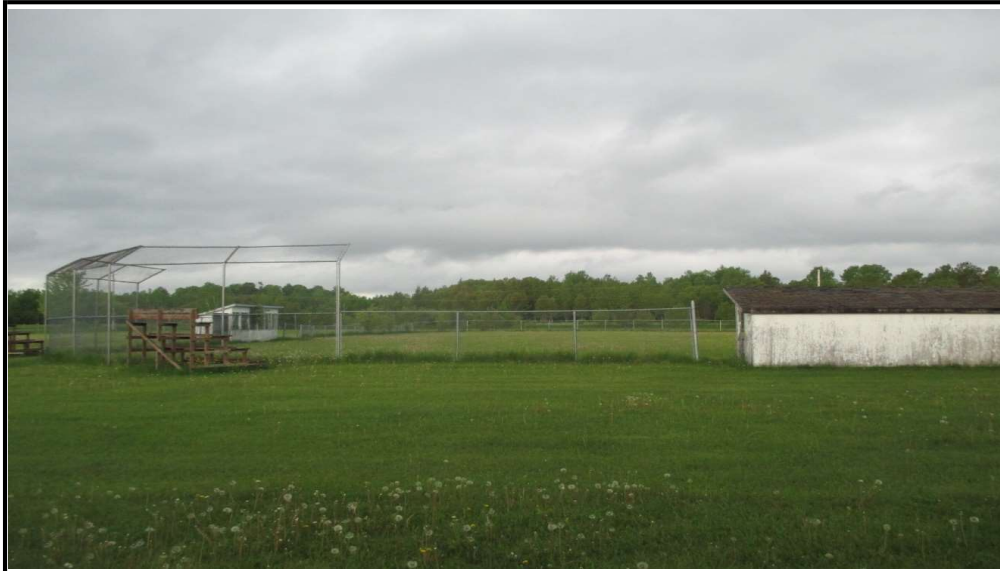
The view of the Ball Diamond

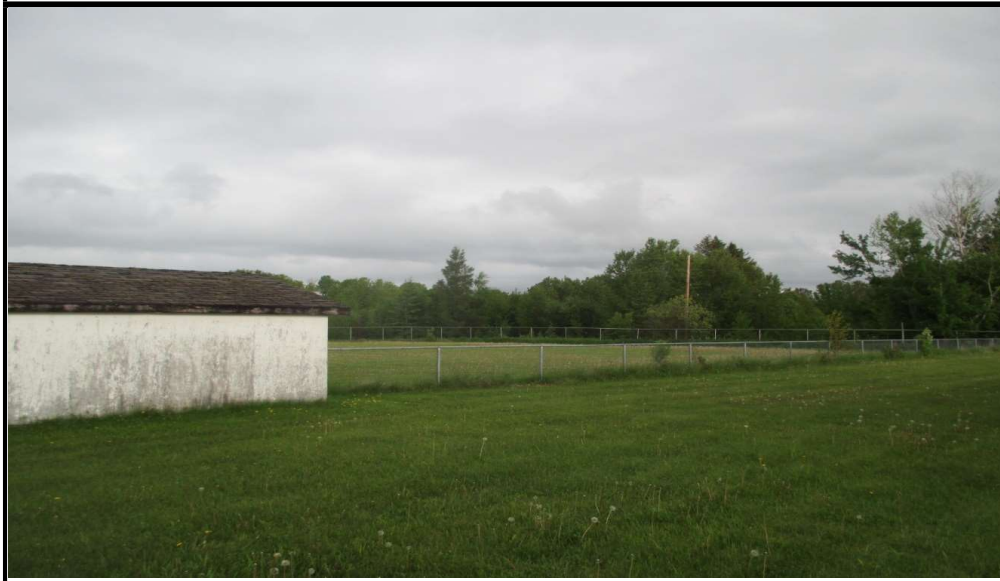
The view of the Ball Diamond
Replace shingles

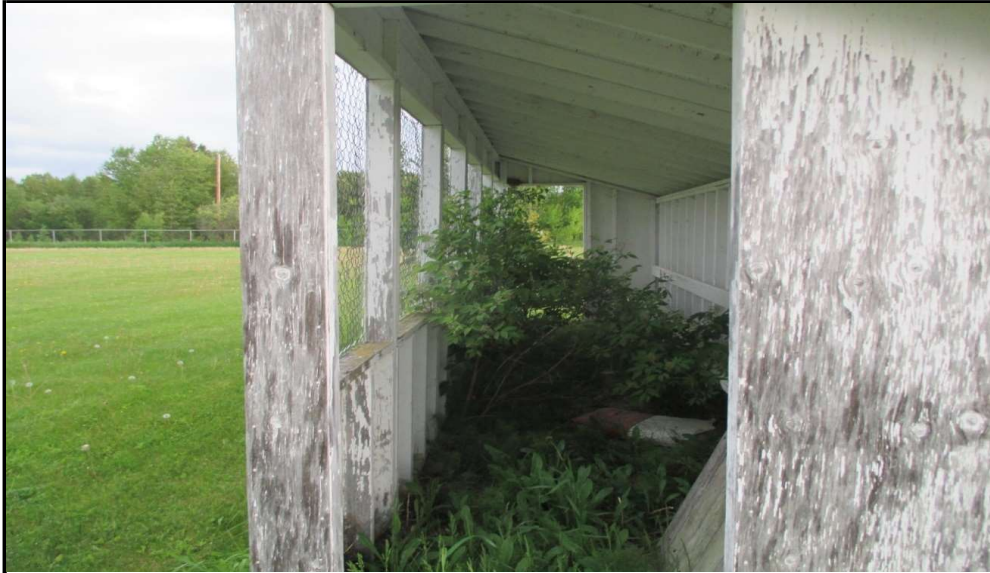
The view of Ball Diamond
Replace rotten fascia on
dugouts and repaint

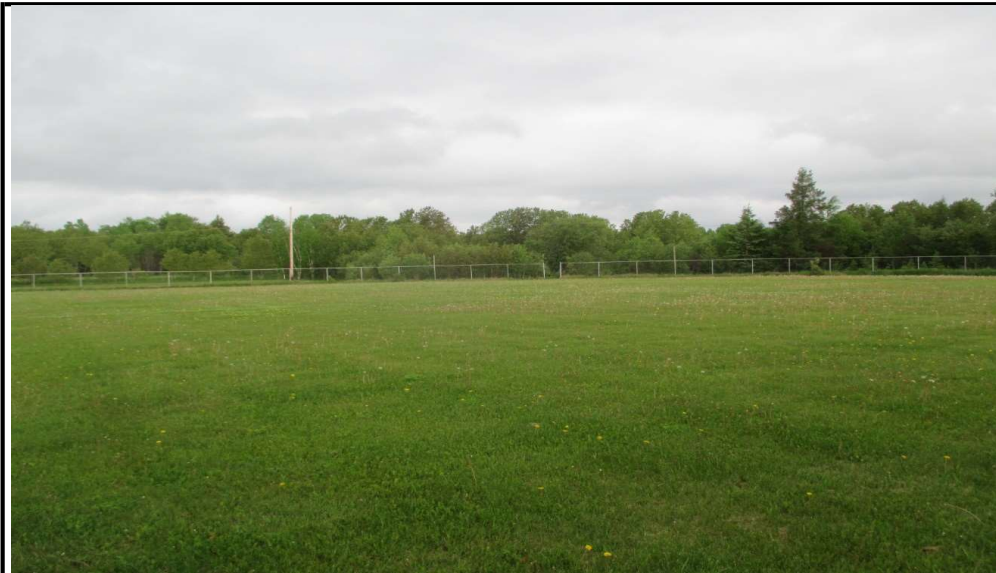
The view of Ball Diamond

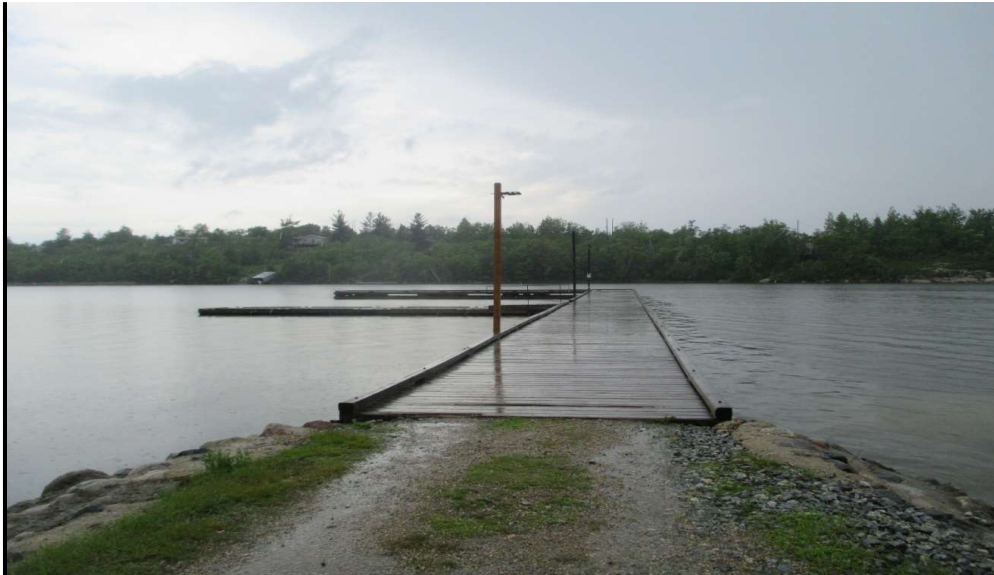
The view of the docks

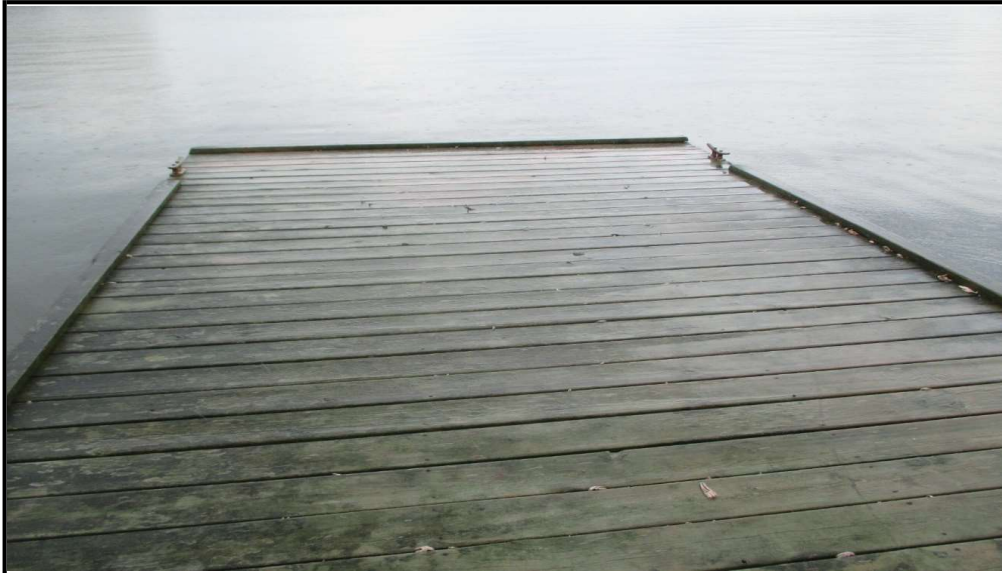
The view of the docks

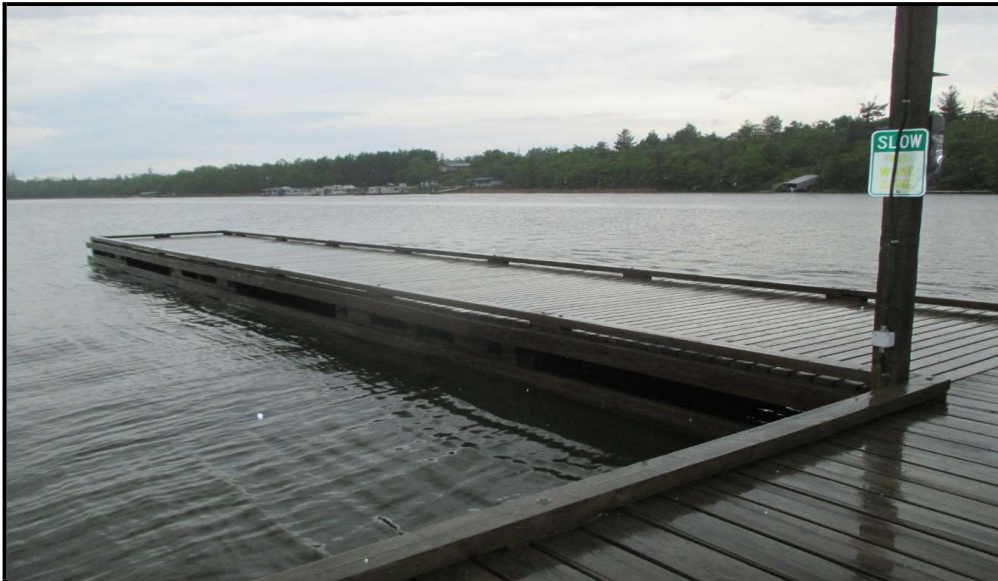
The view of the docks

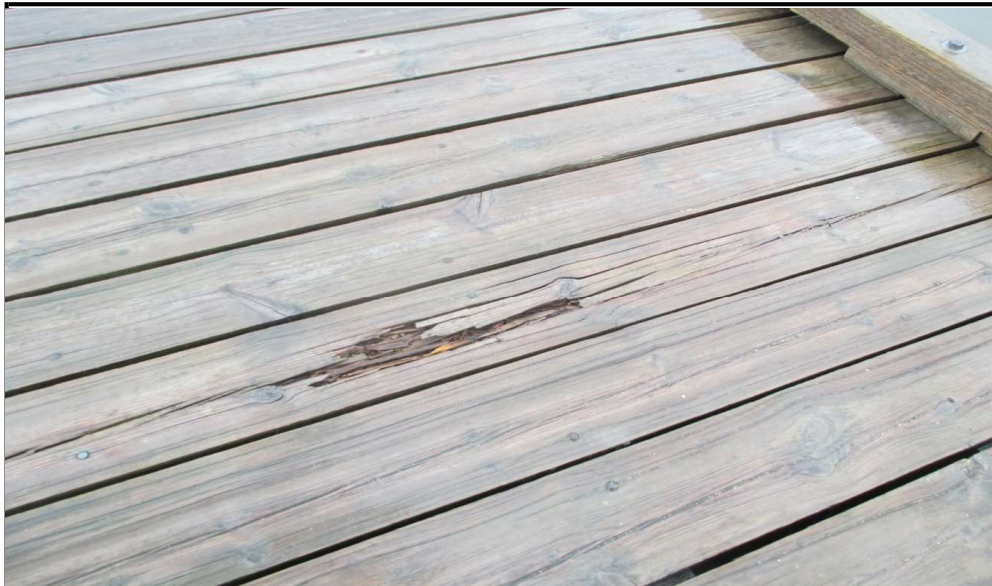
The view of the docks

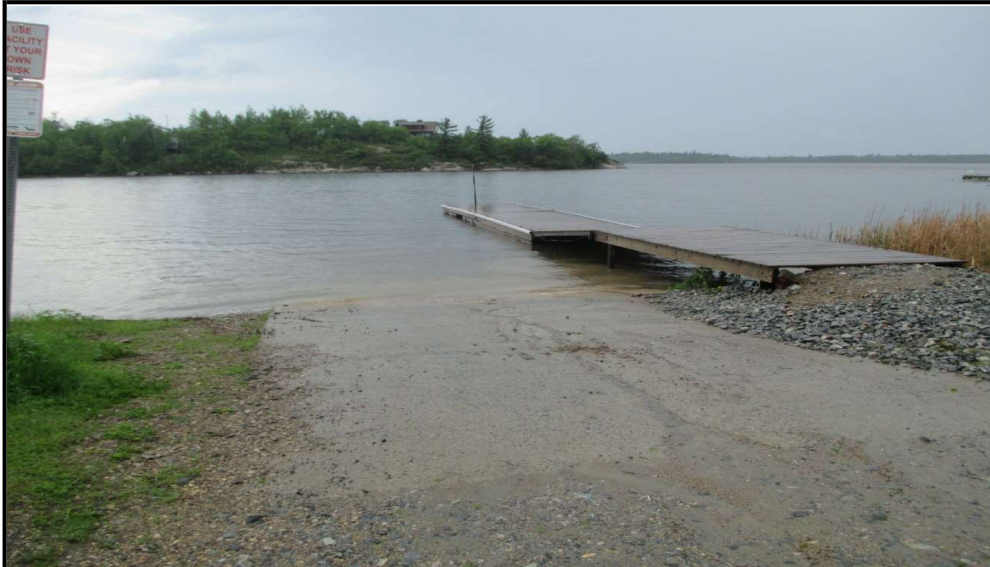
The view of the docks
Add fill at the fixed docks

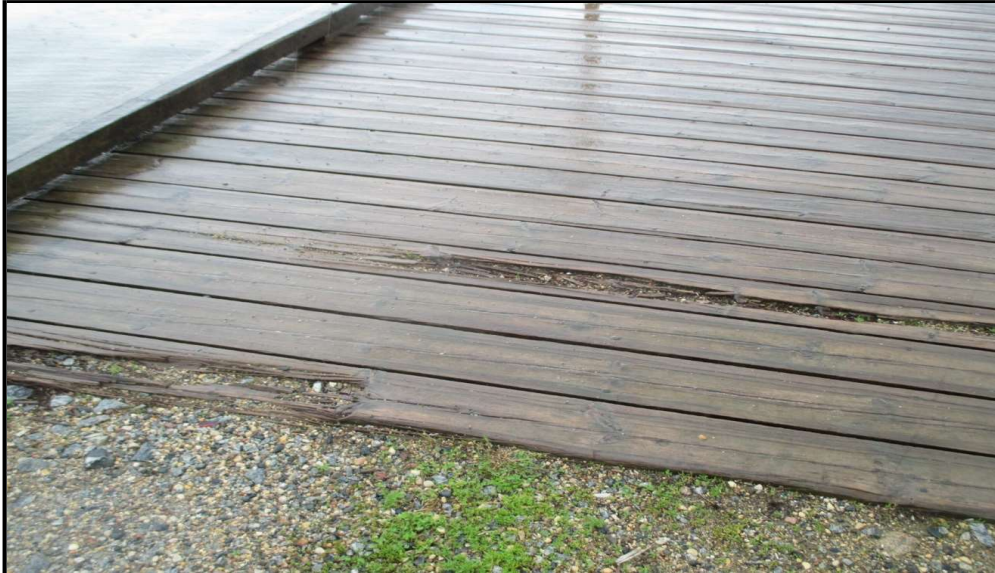
The view of the docks

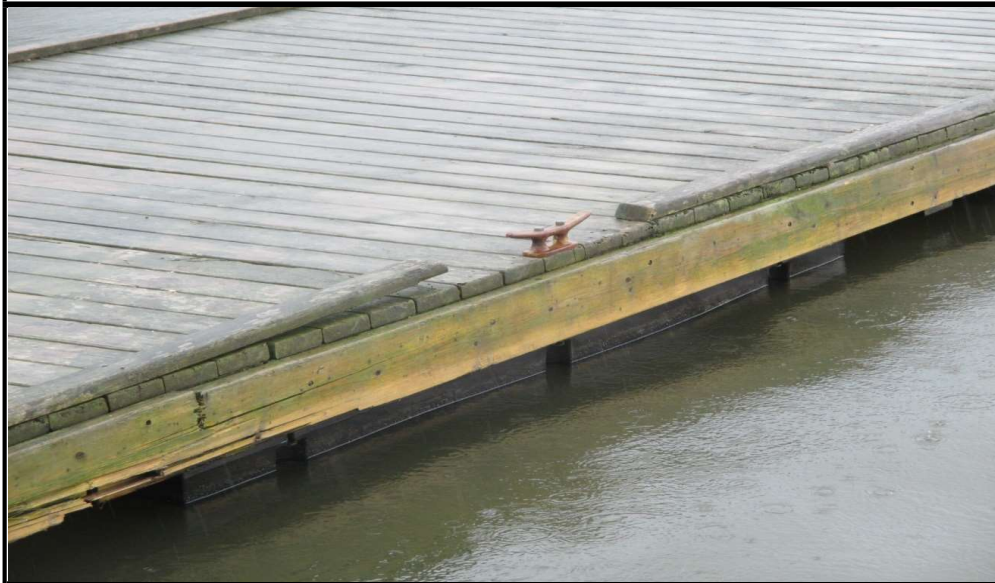
Repair loose rail boards

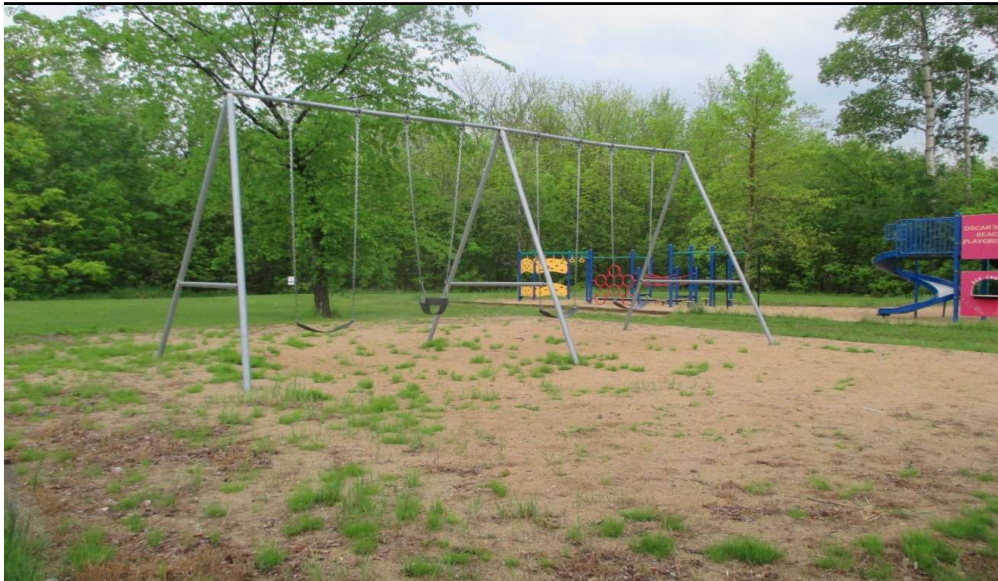
Photo No.:
 Description:
 View of Swings

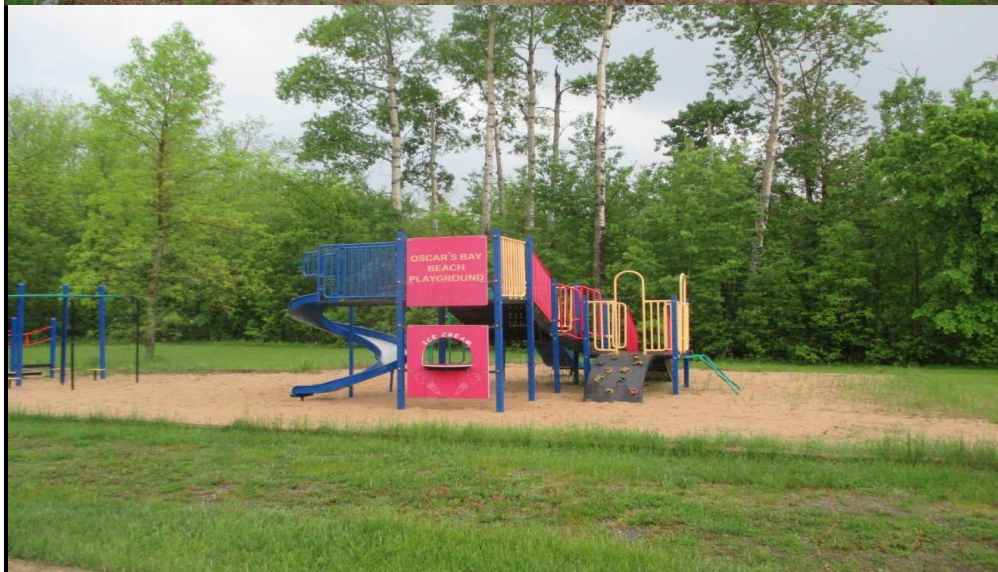
Photo No.:
 Description:
 View of slides

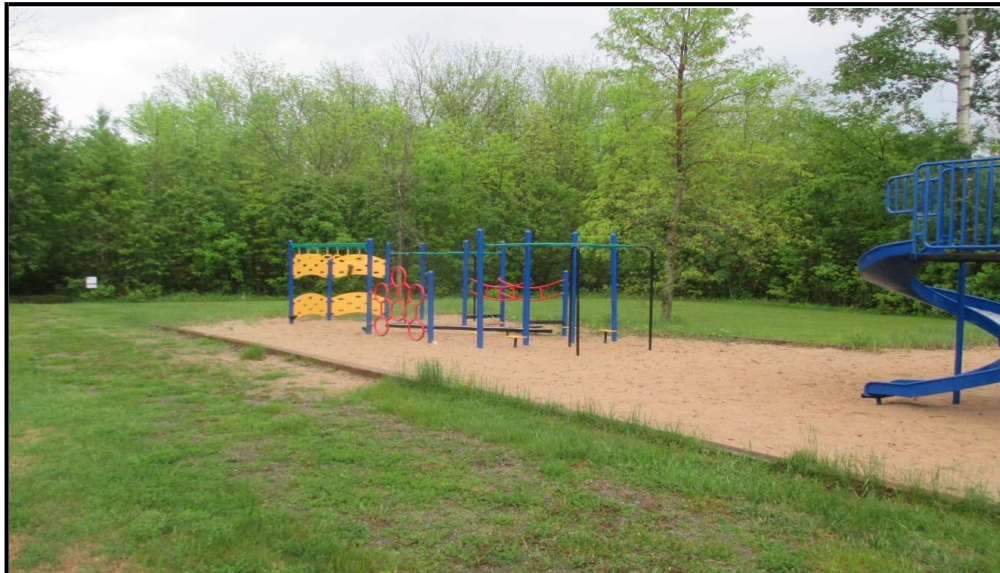
Photo No.:
 Description:
 View of Monkey bar

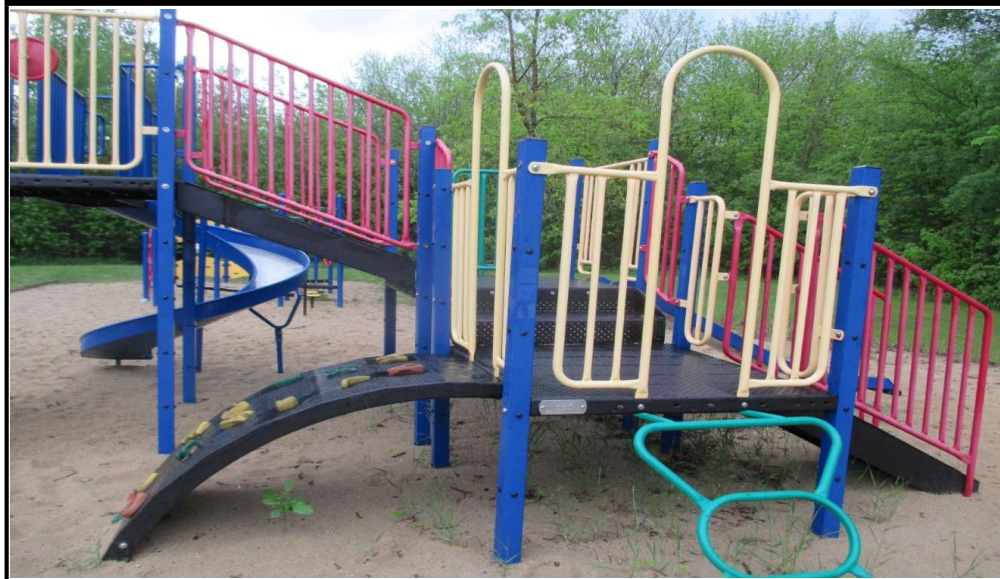
Photo No.:
 Description:
 View of slides

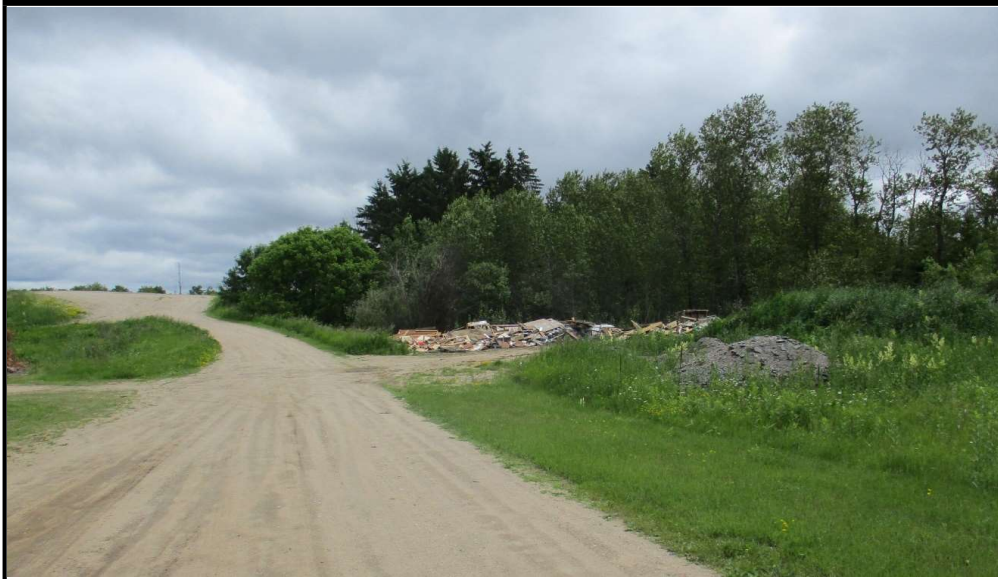
View of Bergland Landfill- wood waste

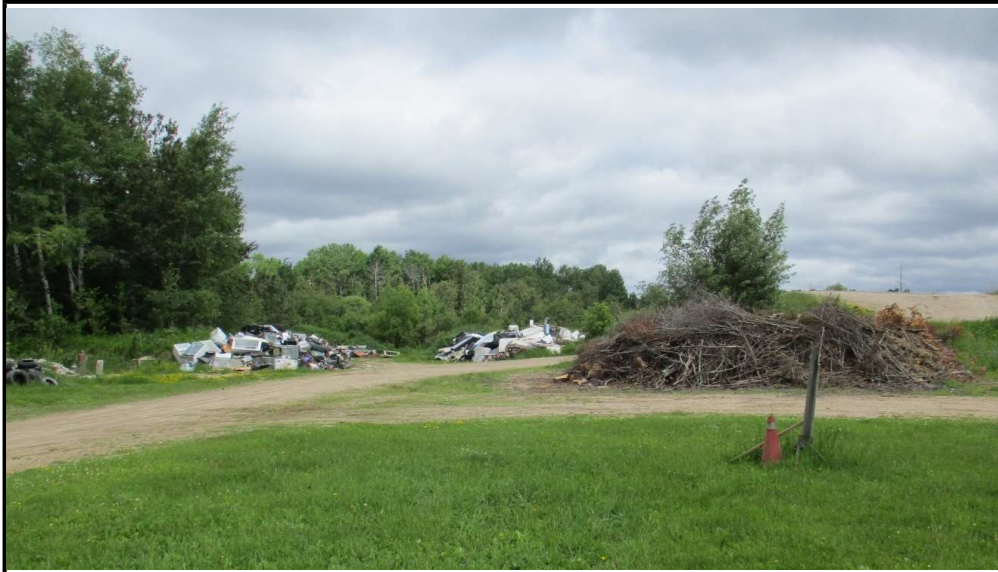
View of Bergland Landfill-
Furniture, Metal and Tires
wastes

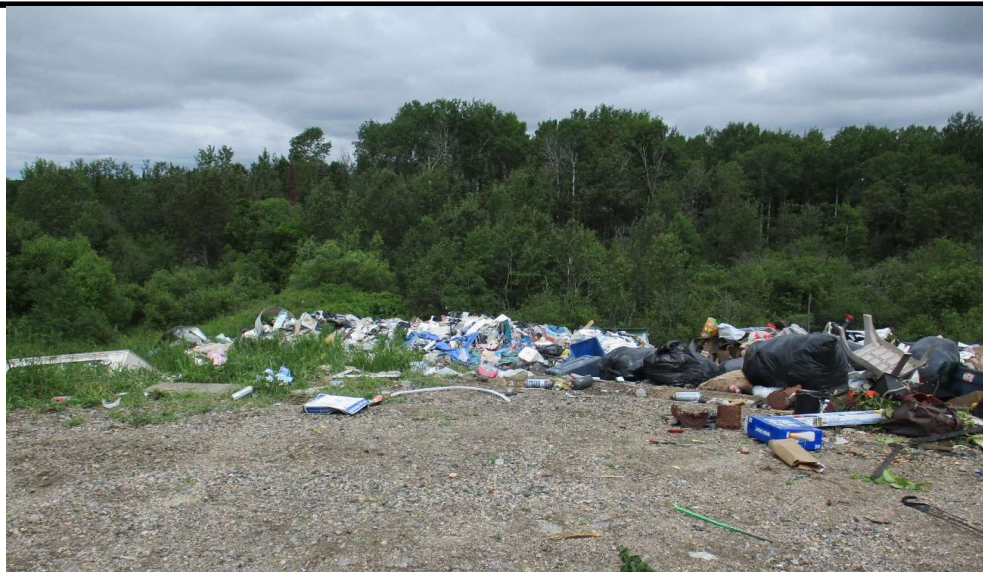
View of Bergland Landfill-
Household waste

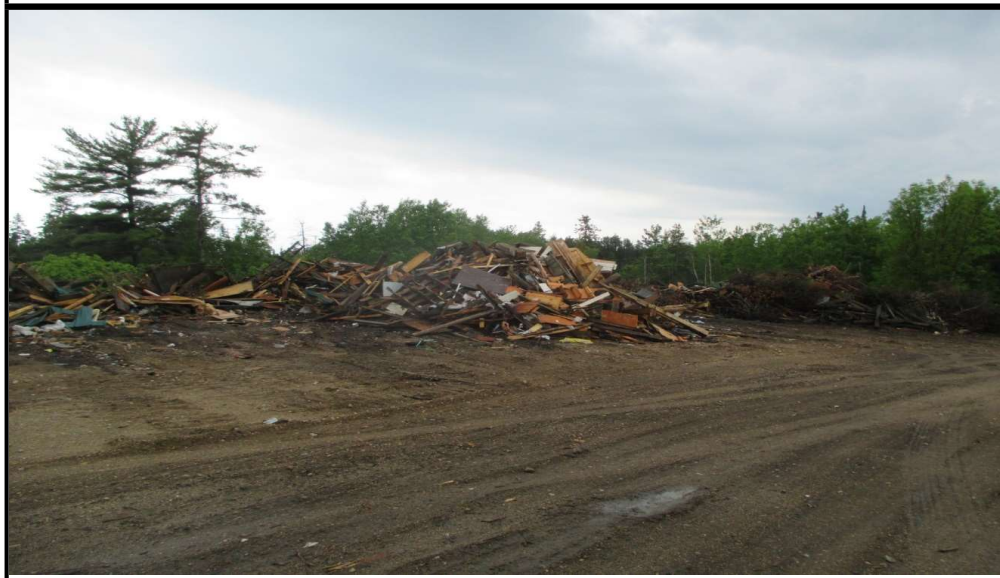
View of Morson Dump

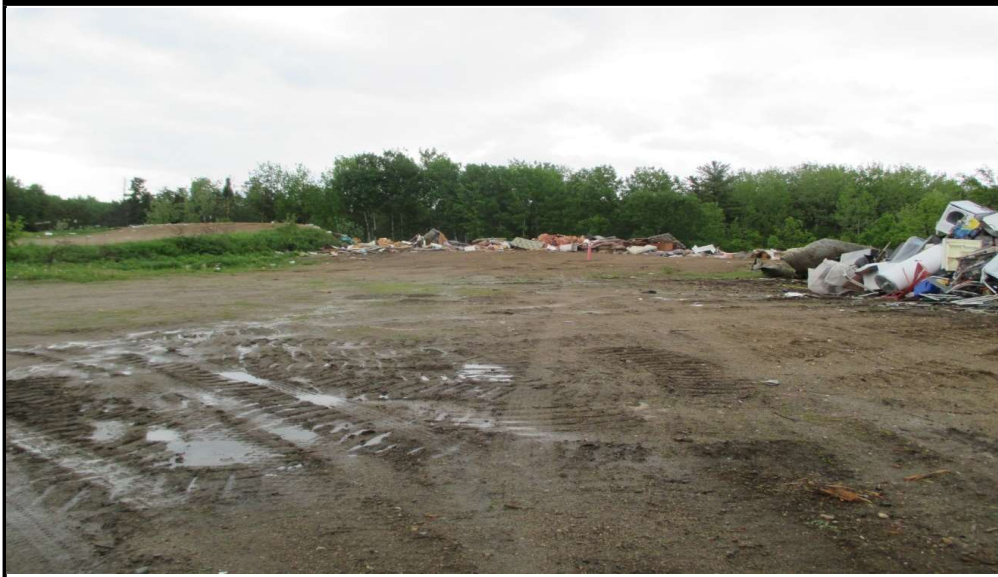
View of Morson Dump- Metal waste

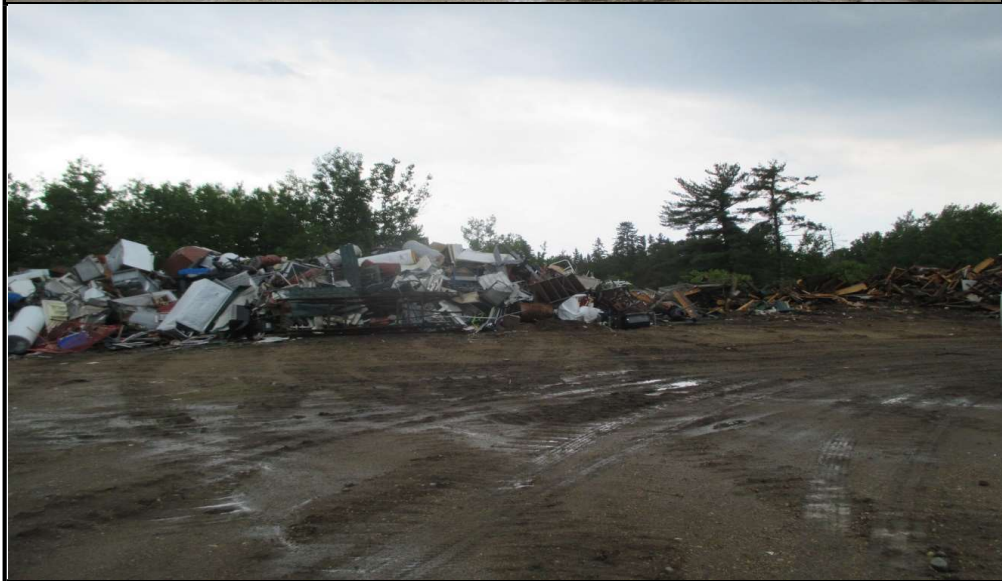
View of Morson Dump-
Household waste

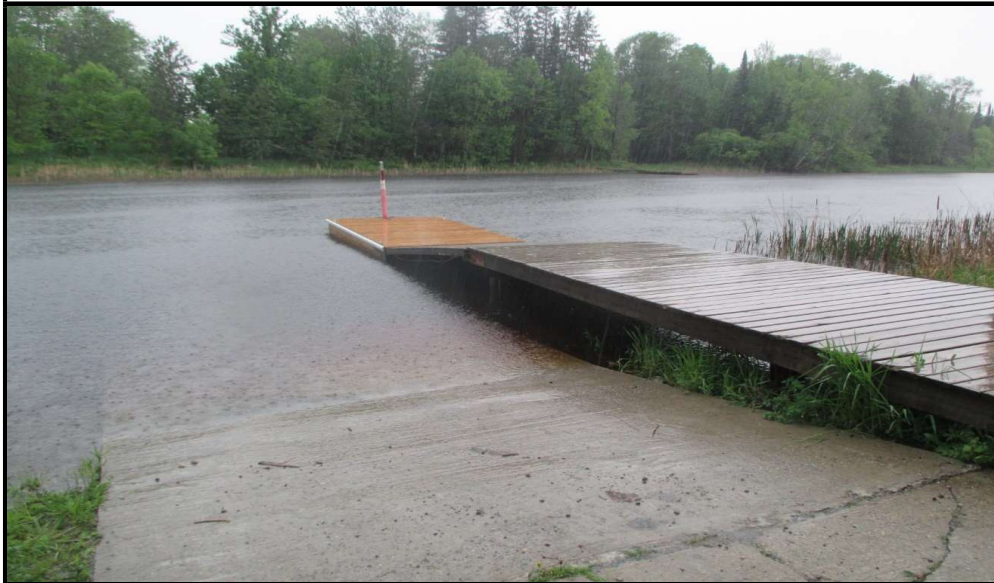
The view of the docks

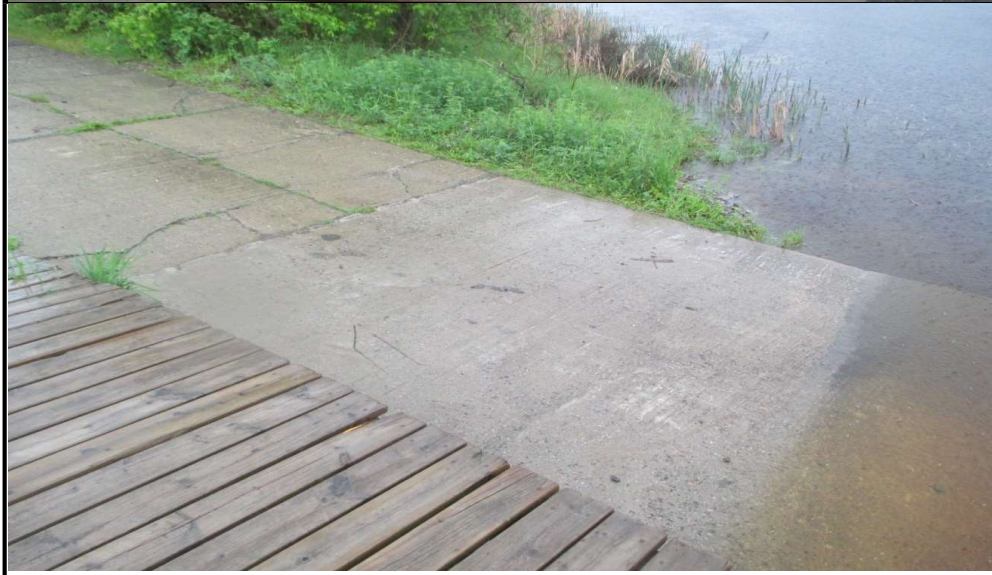
The view of the docks

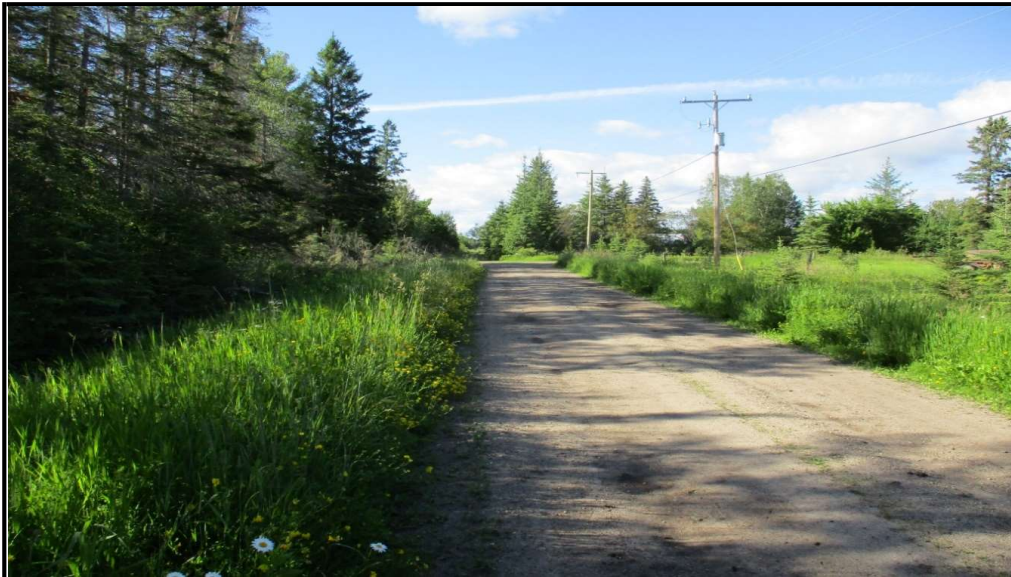
Photo No.: 1

The asset is in fair condition and requires some maintenance.

View of road heading North.
Grade road.

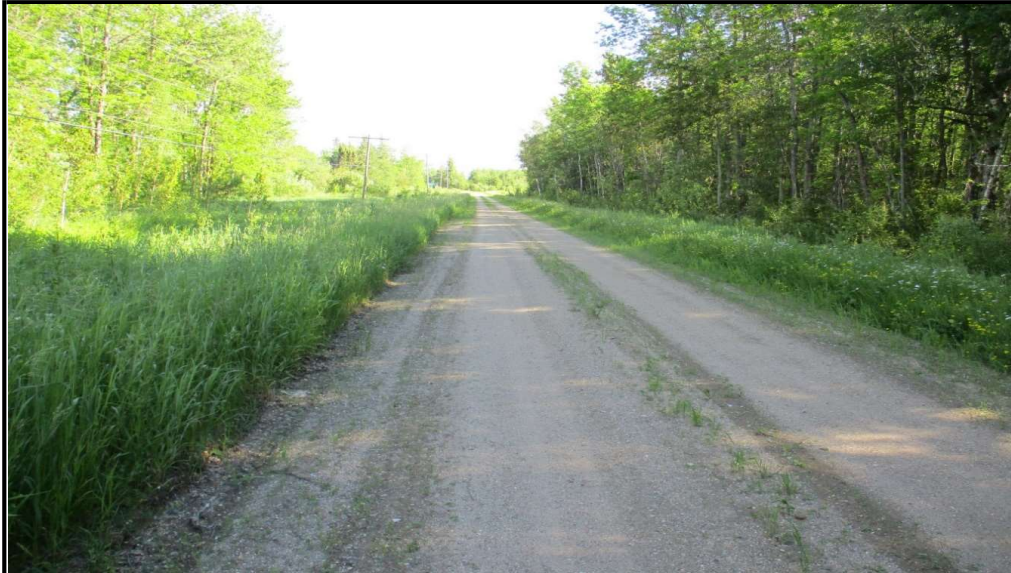
Photo No.: 1

View of road heading South-
Widen road by 1m, Provide 2
speed limit signs

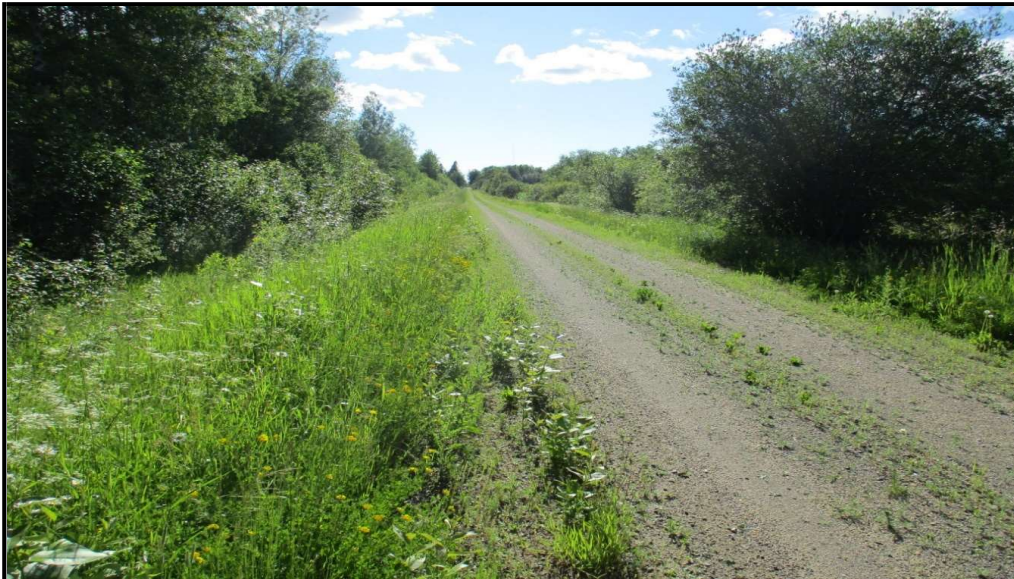
Photo No.: 1

View of road heading West-
Widen road by 1.5m. Provide 3
speed limit signs

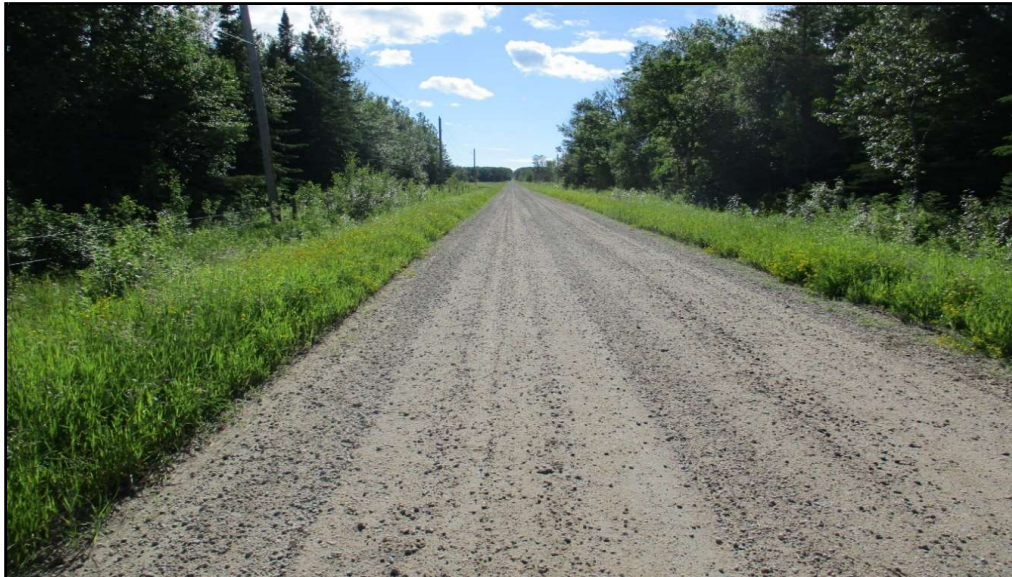
Photo No.: 1

View of road heading West-
Widen road by 1m, Provide 2
speed limit signs

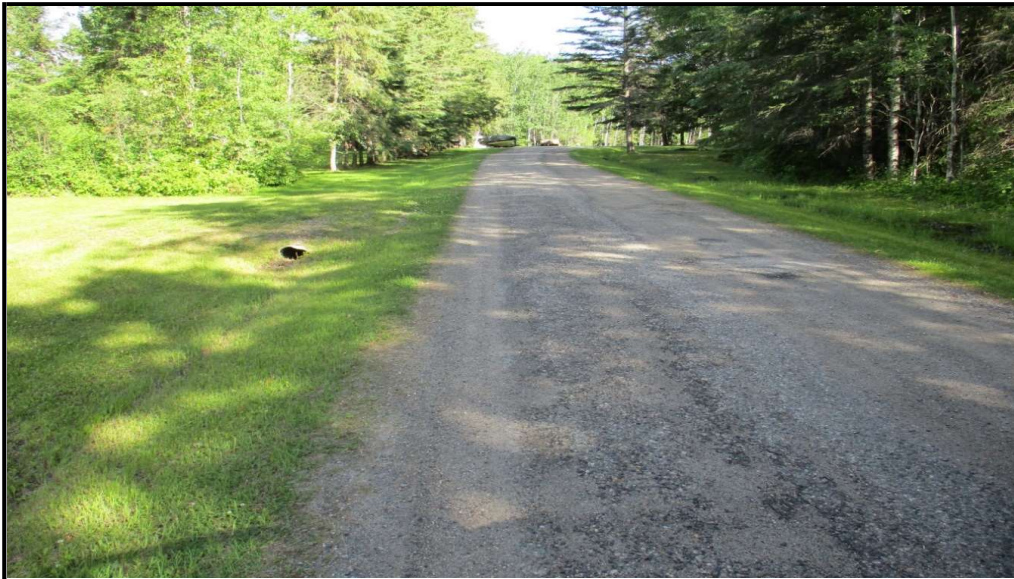
Photo No.: 1

The view of the road facing South-East-
Widen Road by 2m Provide 2 speed limit signs
