2024 ASSET MANAGEMENT PLAN

Lake of the Woods
PO Box 427
Rainy River, ON, P0W 1L0

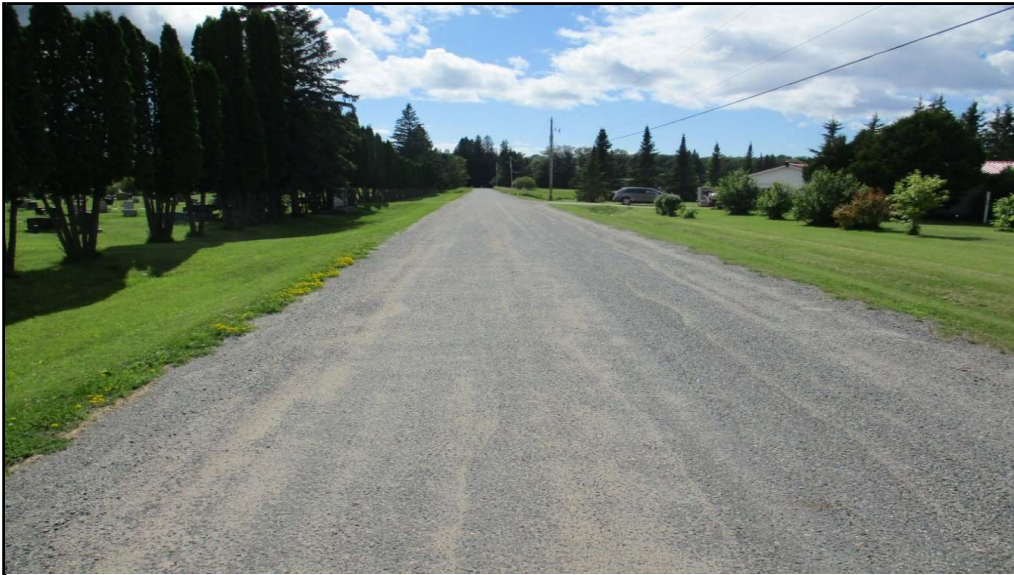
Photo No.: 1

The view of the road facing West-
Cut brush in ditches & shoulder

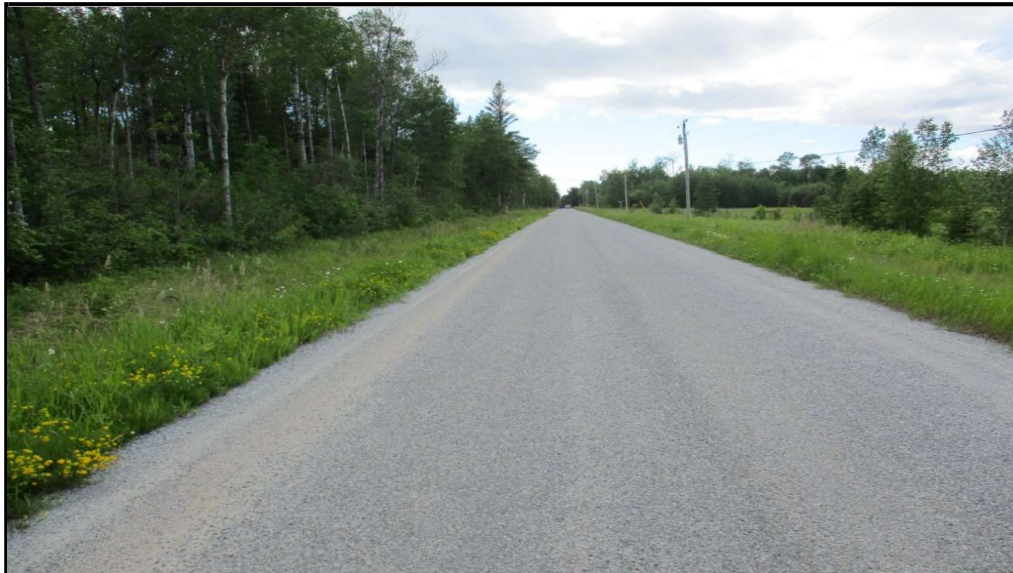
Photo No.: 1
 Description:
 View of road heading West. Cut
 brush in ditches & shoulder
 (light).

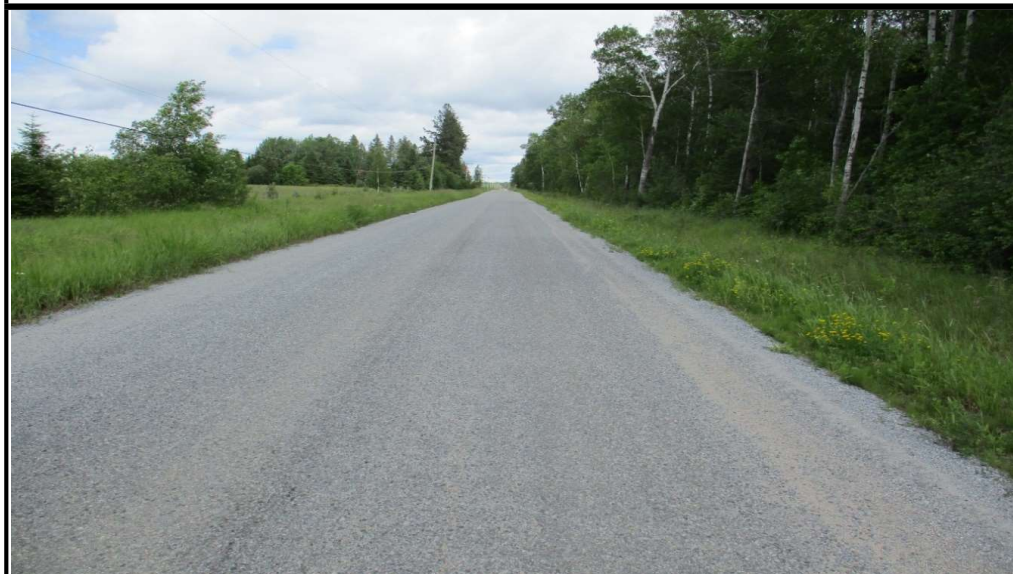
Photo No.: 2
 Description:
 View of road heading East.
 Install 2 speed limit signs.

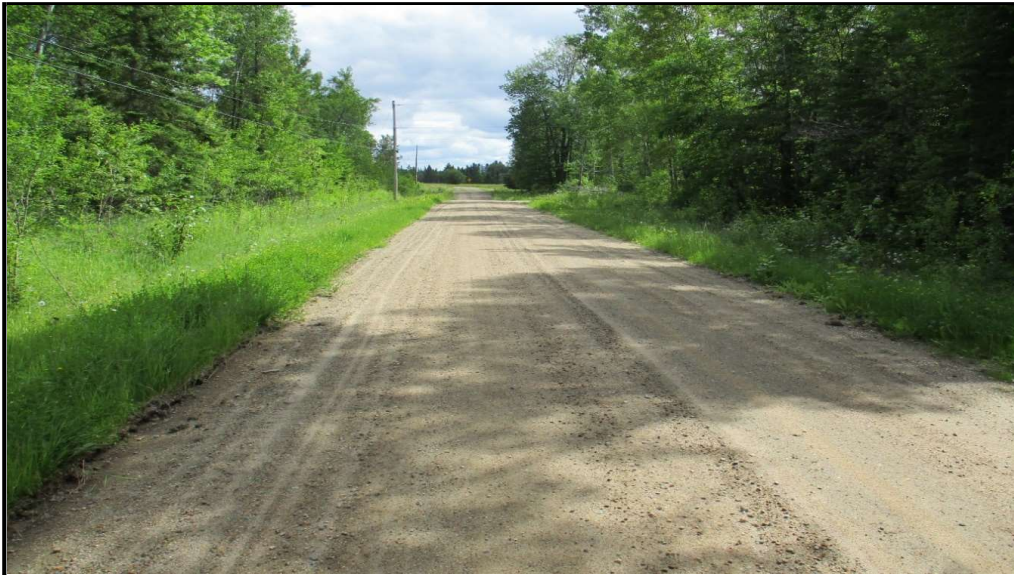
Photo No.: 1

The view of the road facing South-
Cut brush in ditches, shoulder and grade shoulder

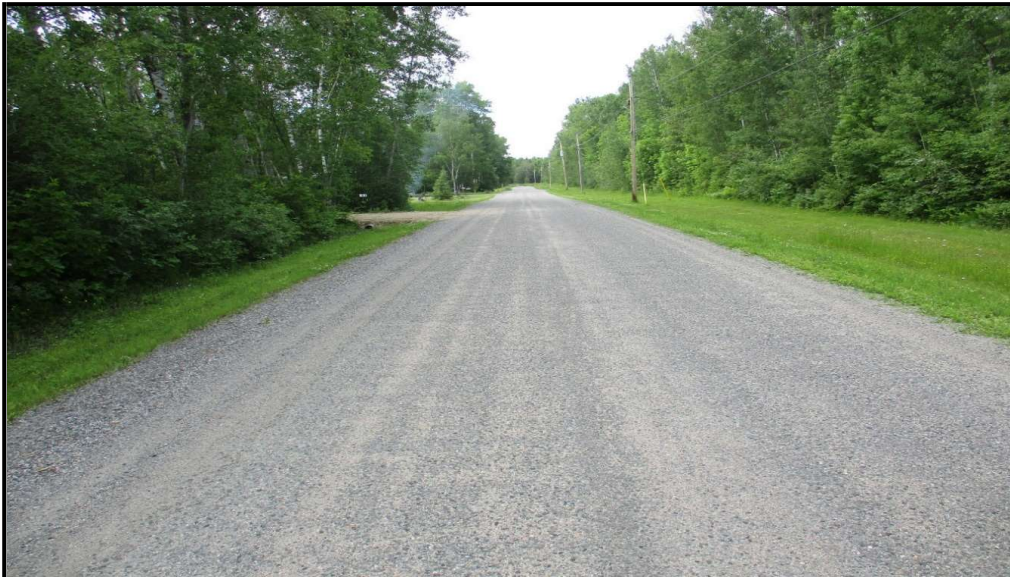
Photo No.: 1

View of road heading North-
Provide speed limit signs

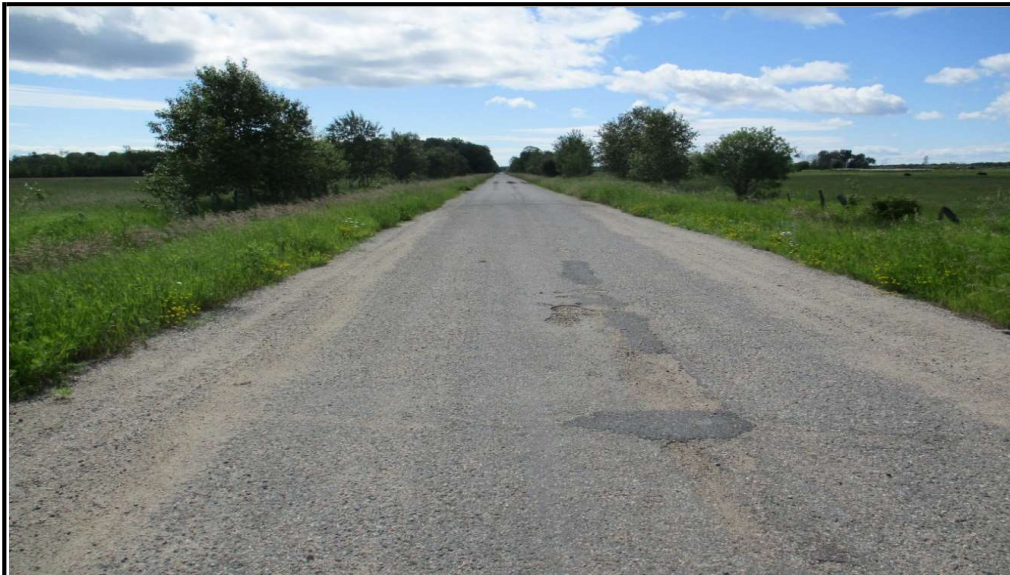
Photo No.: 1

View of road heading West-
Patching & Sealing

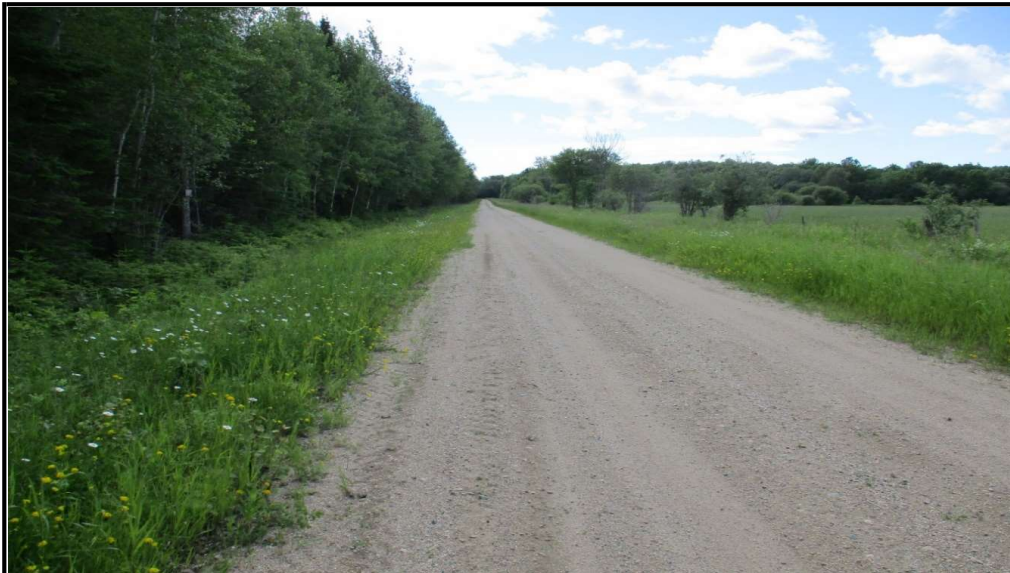
Photo No.: 1

View of road heading West-
Grade road

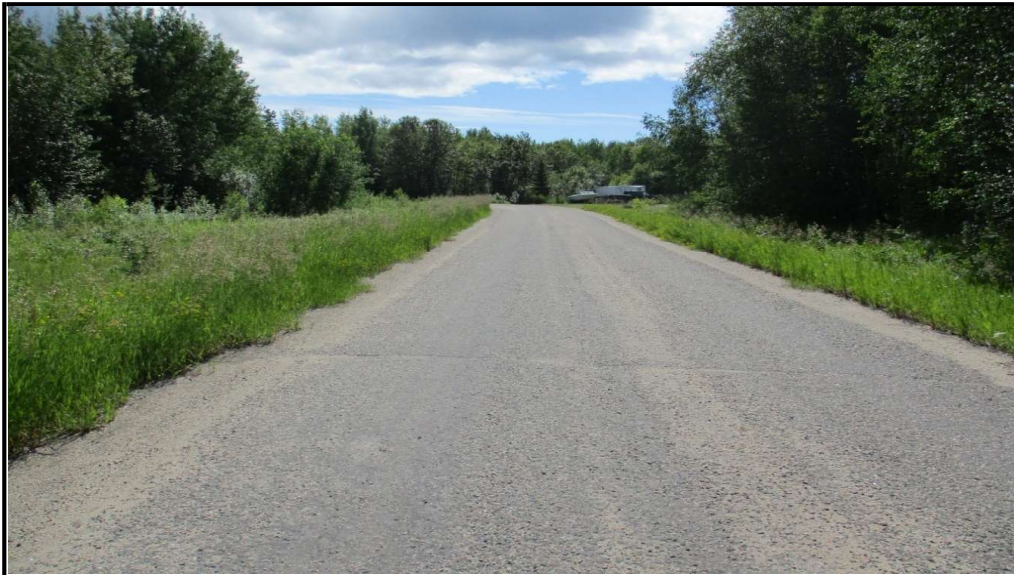
Photo No.: 1

View of road heading South-West
Widen road by 0.8m

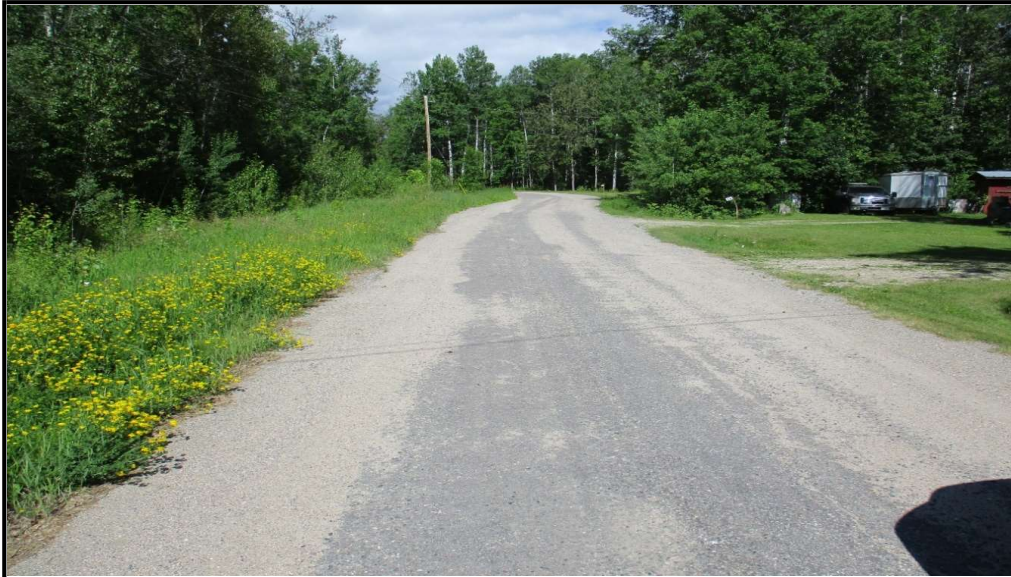
Photo No.: 1

View of road heading North-East-
Widen road by 1m

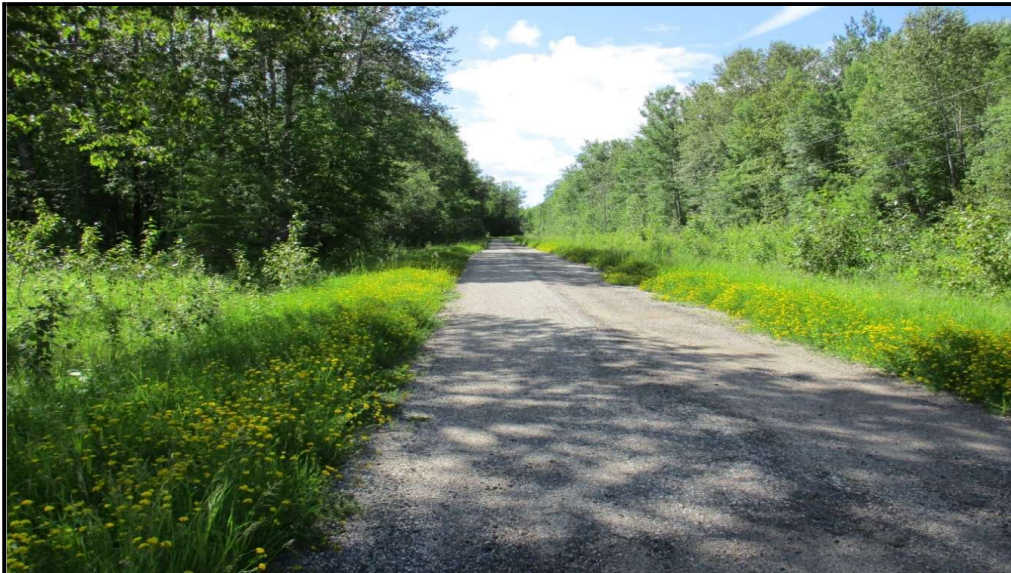
Photo No.: 1

View of road heading West-
Widen road by 1.3m

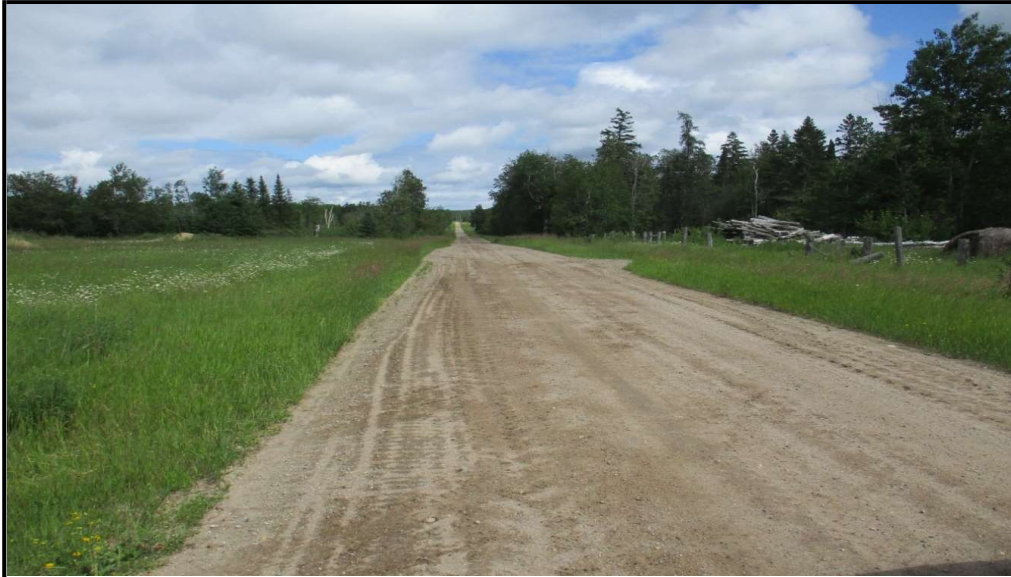
Photo No.: 1

View of road heading East-
Cut brush in ditches & shoulder
(light)

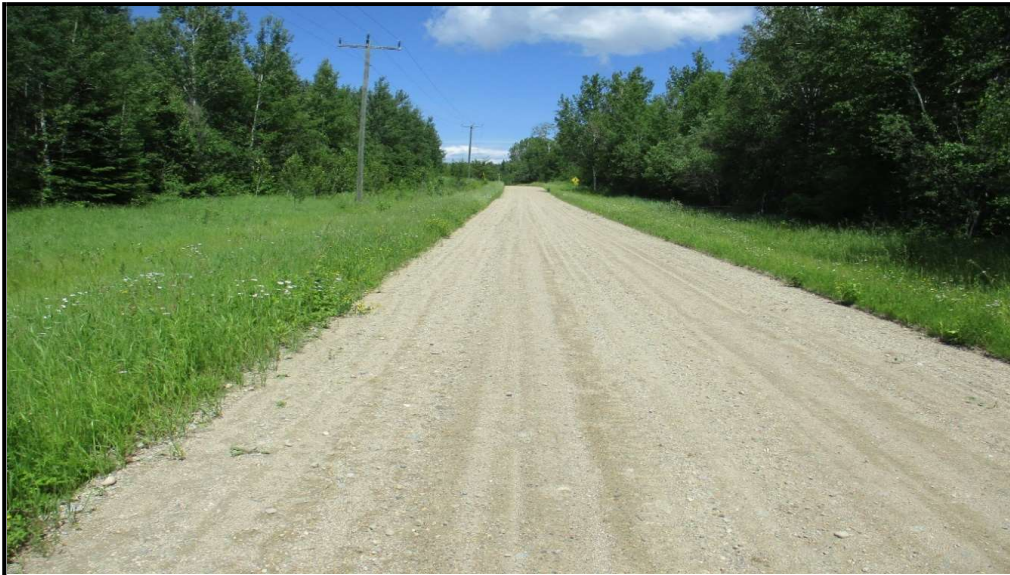
Photo No.: 1

View of road heading West-
Widen road by 0.6m, Install 6
speed limit signs

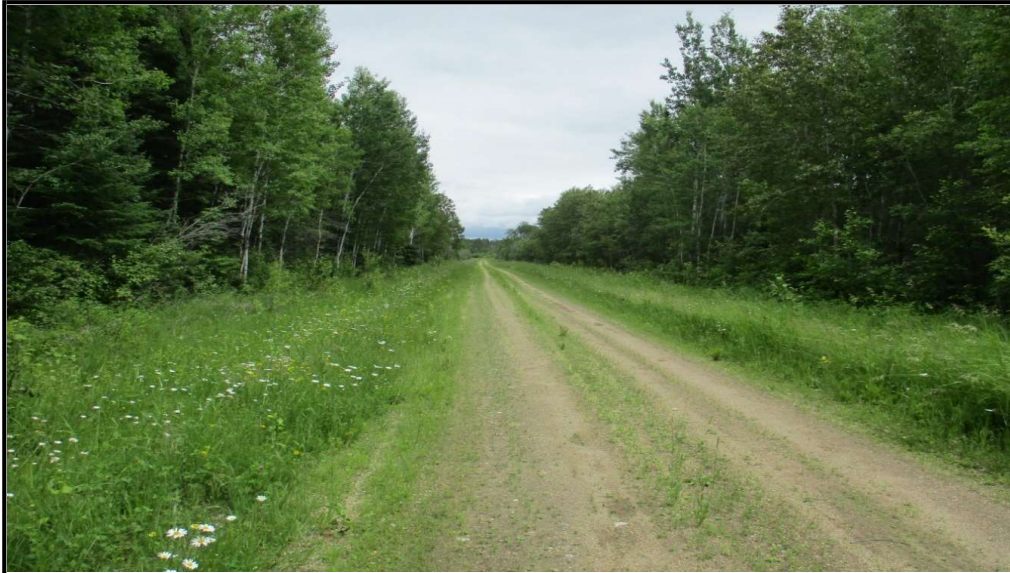
Photo No.: 1

View of road heading East-
Widen road by 2m, Install 2
speed limit signs

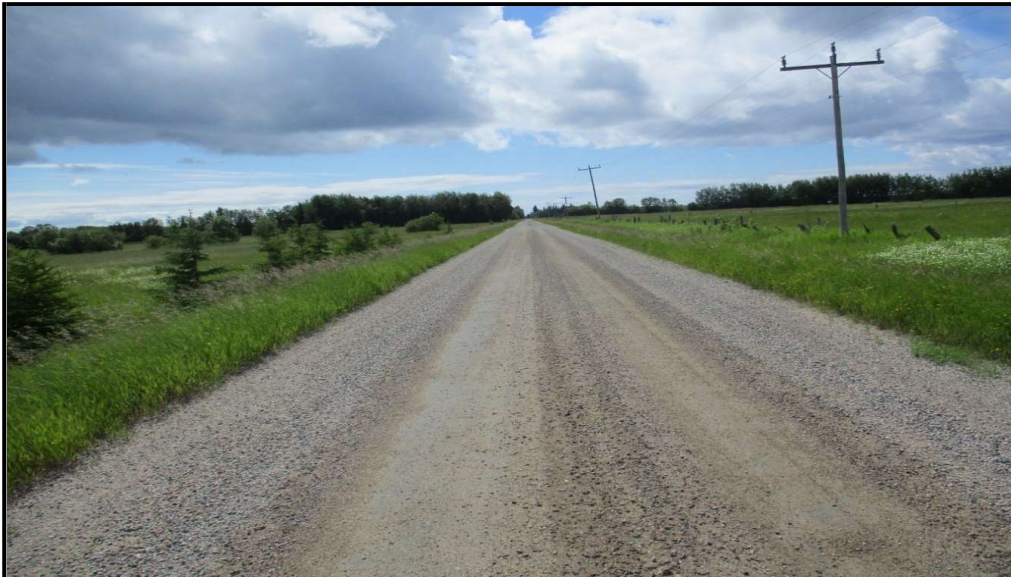
Photo No.: 1

View of road heading West-
Cut brush in ditches & shoulder
(light)

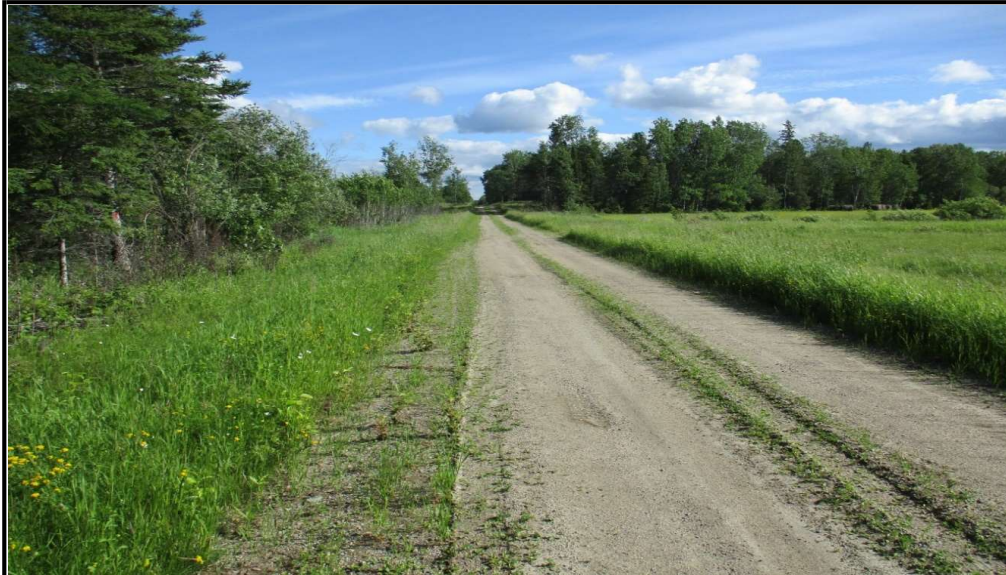
Photo No.: 1

View of road heading South-
Widen road by 1.3m, Grade
road, Install 2 speed limit signs

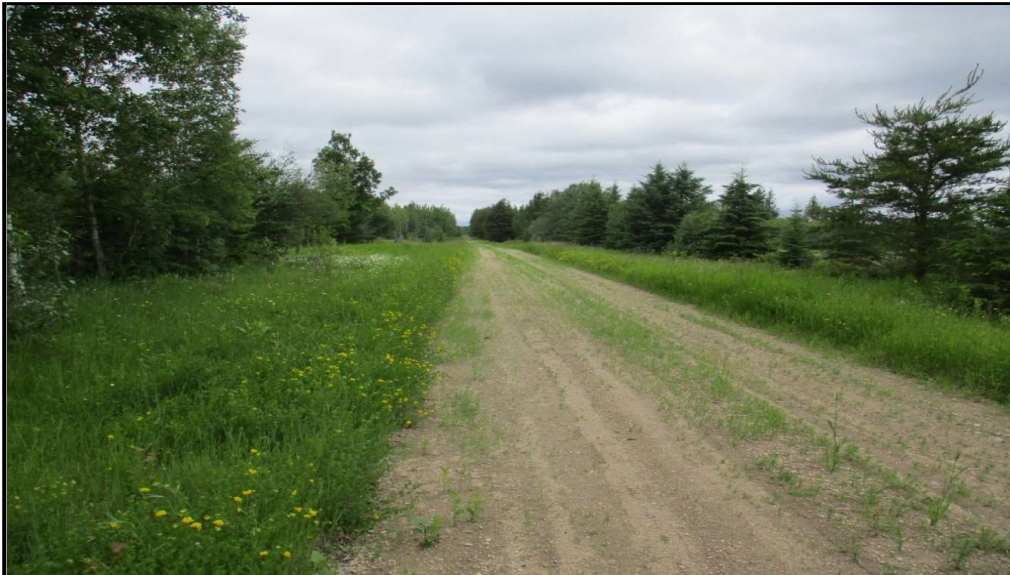
Photo No.: 1

View of road heading North-
Widen road by 1.5m, Grade
road, Install speed limit signs

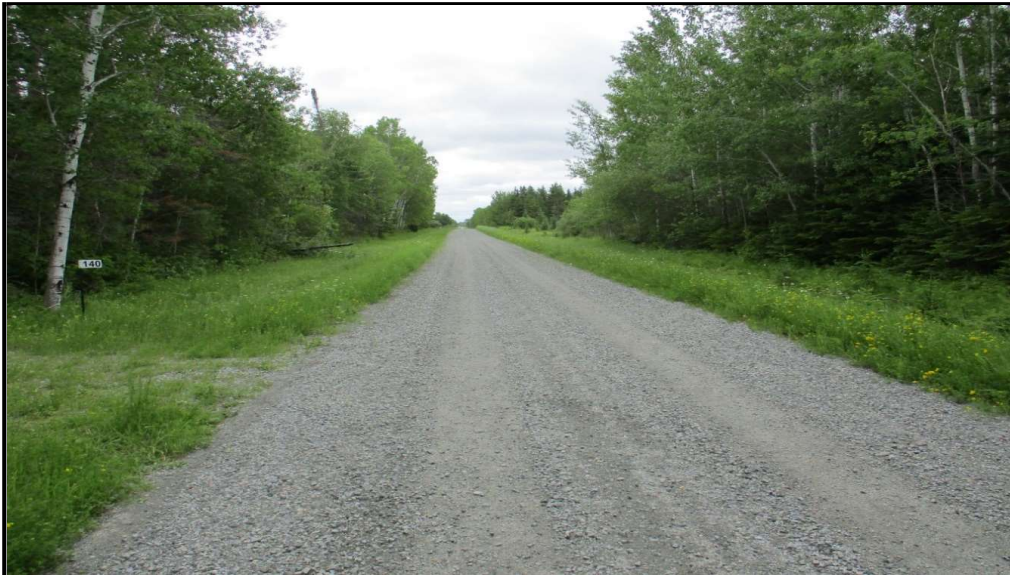
Photo No.: 1

View of road heading South-
Cut brush in ditches & shoulder
(light)

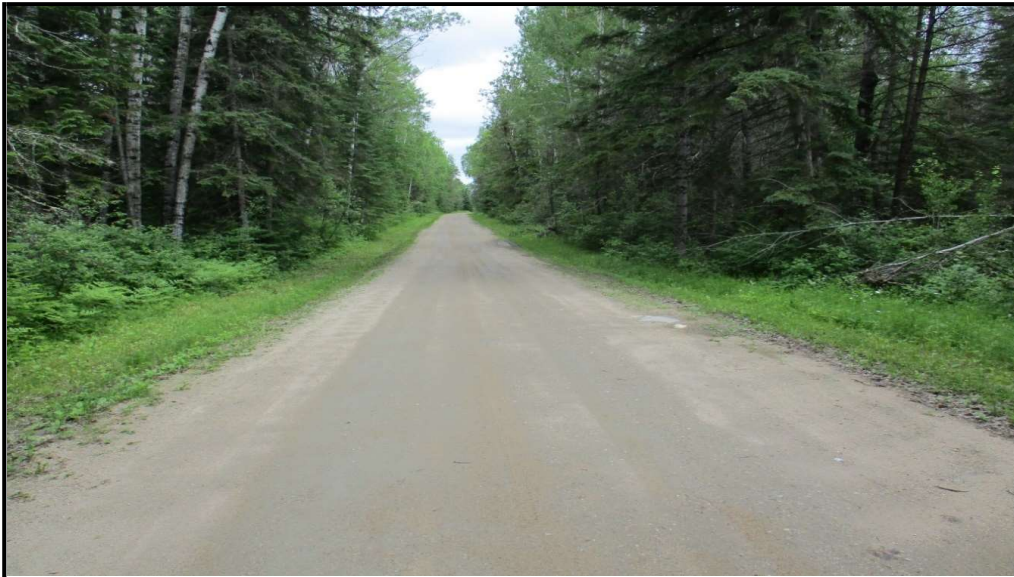
Photo No.: 1

View of road heading North-
Widen road by 1.5m

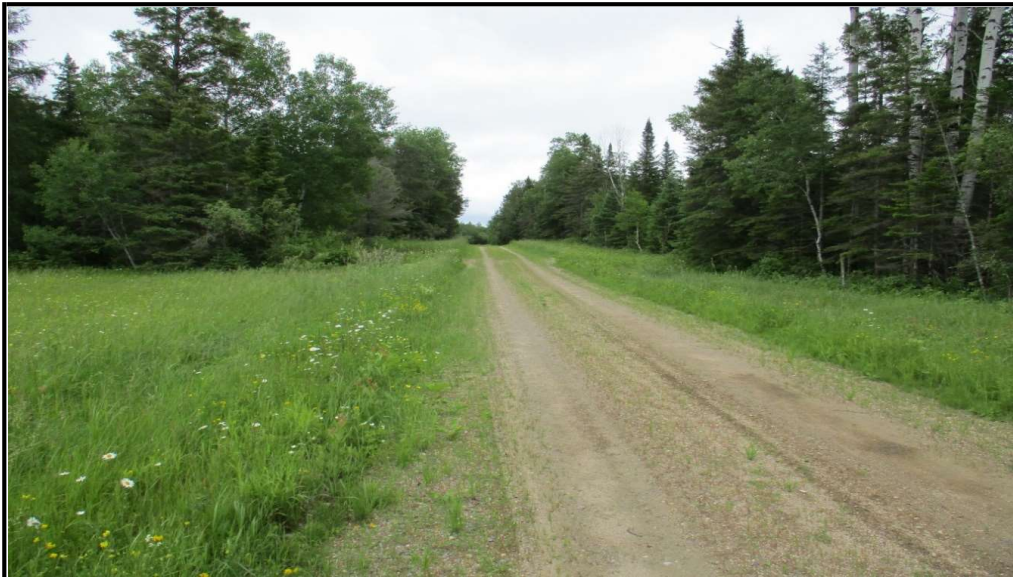
Photo No.: 1

View of road heading East-
Grade road, Install 2 speed limit
signs

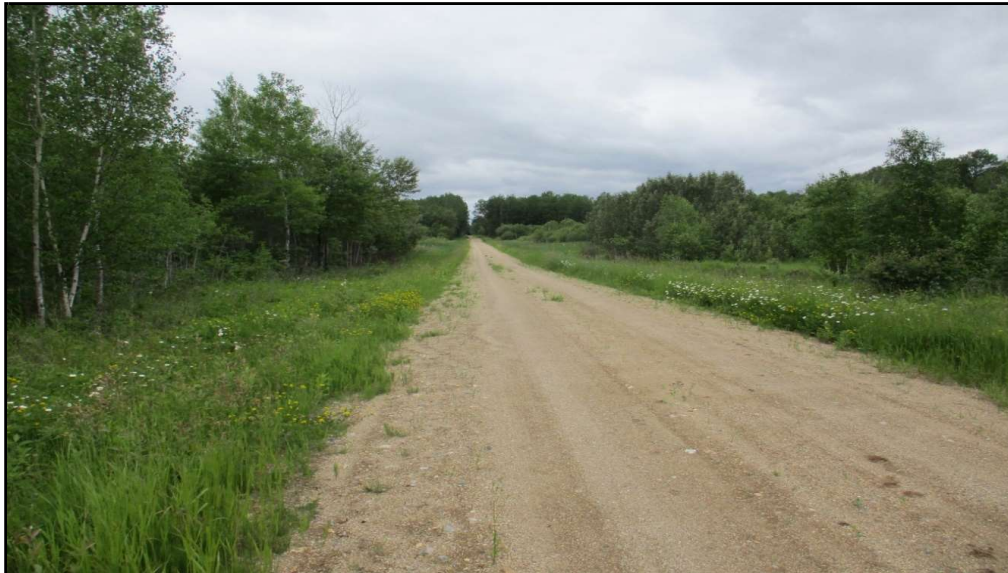
Photo No.: 1

View of road heading West-
Cut brush in ditches & shoulder
(light)

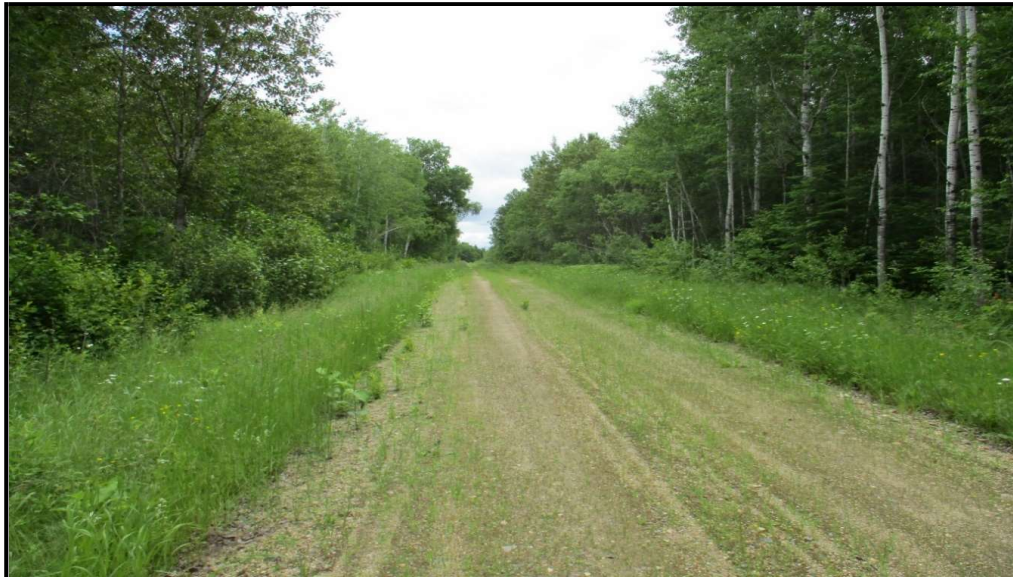
Photo No.: 1
 Description:
 View of road heading East-
 Widen road by 2.2m

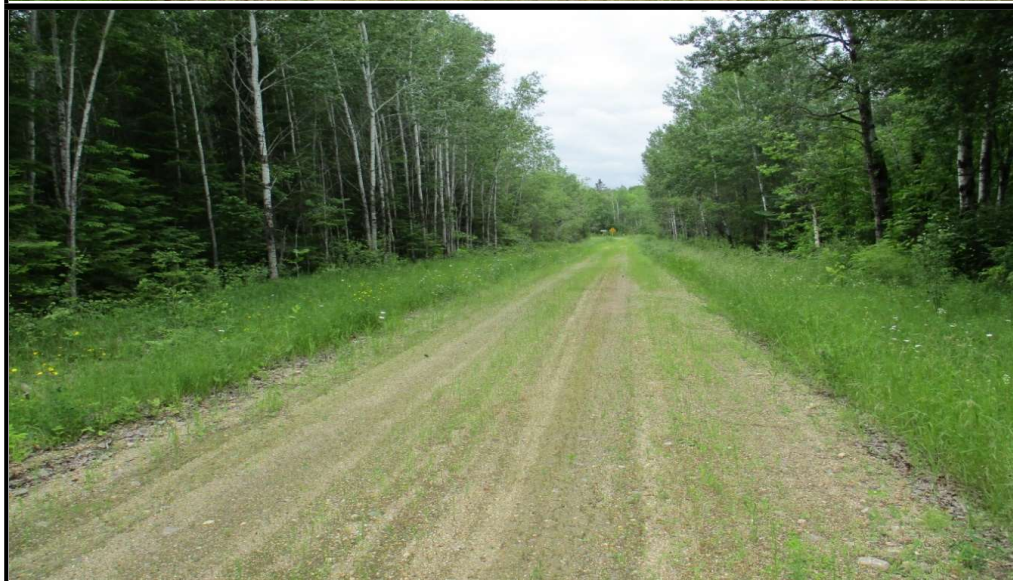
Photo No.: 2
 Description:
 View of road heading West-
 Cut brush in ditches & shoulder
 (light)

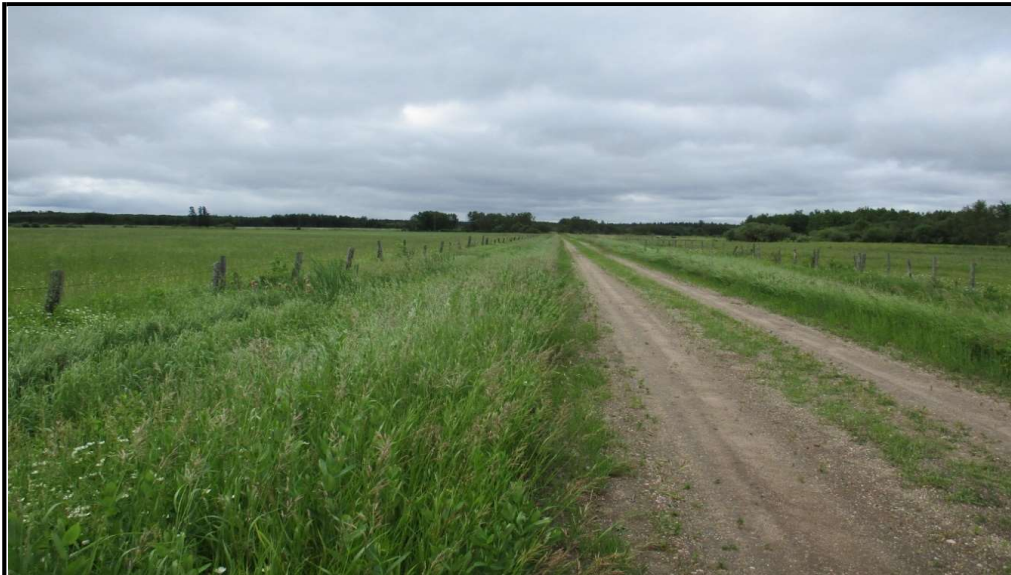
Photo No.: 1

View of road heading South-
Cut brush in ditches & shoulder
(light)

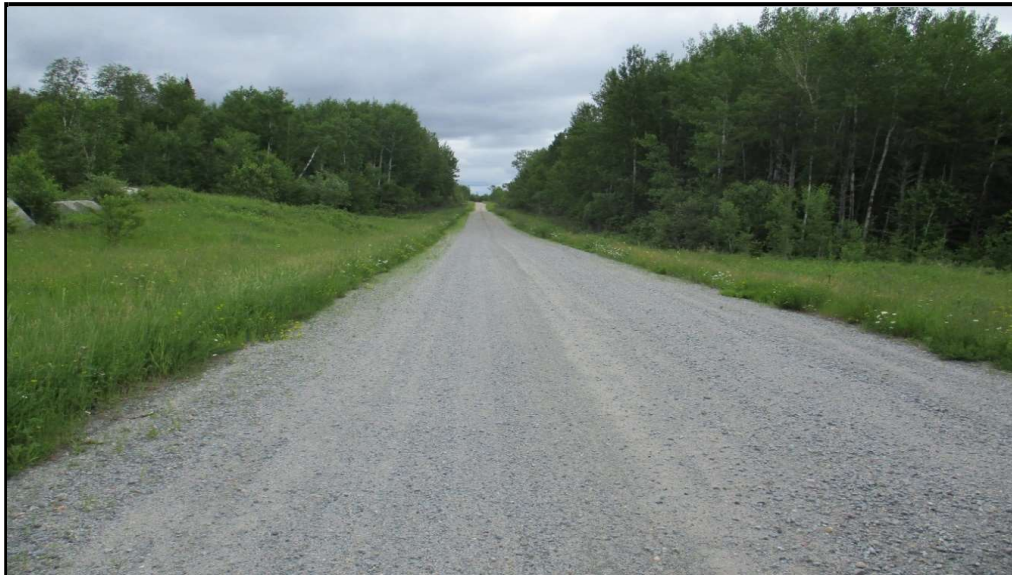
Photo No.: 1

View of road heading East-
Cut brush in ditches & shoulder
(light)

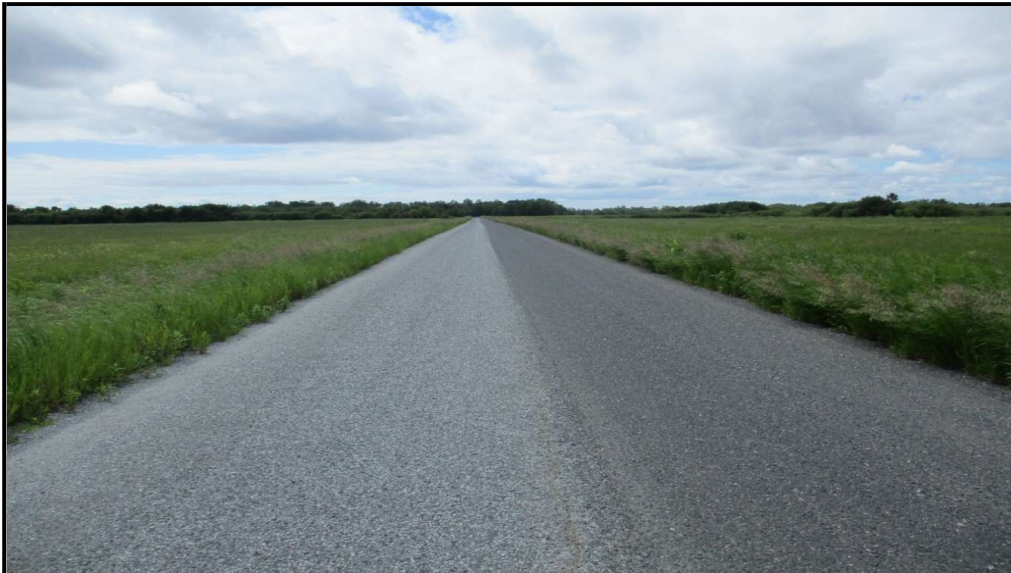
Photo No.: 1

View of road heading West-
Cut brush in ditches & shoulder
(light)

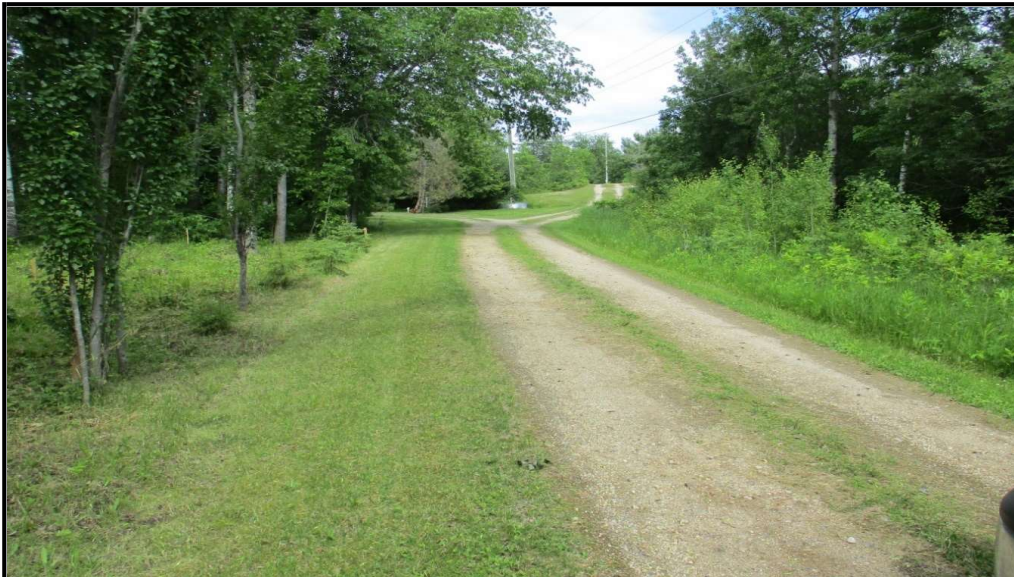
Photo No.: 1

View of road heading North-East

Widen road by 2.1m

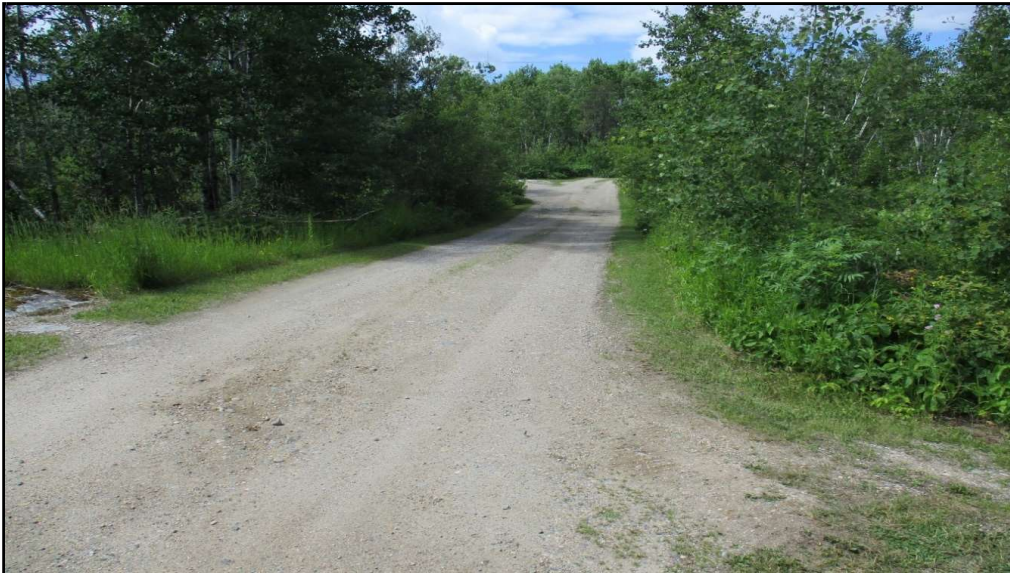
Photo No.: 1

View of road heading North-West

Widen road by 2.3m

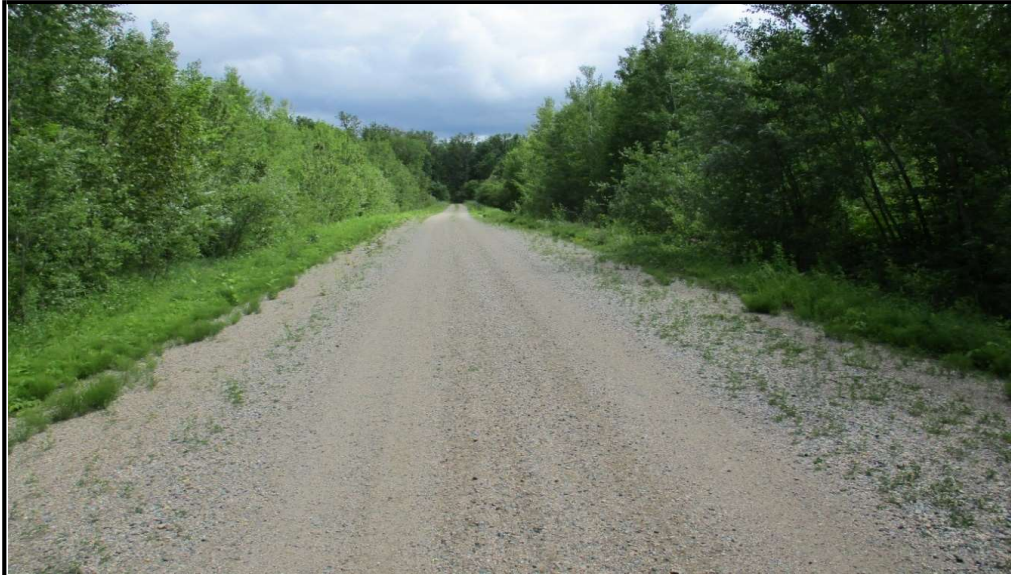
Photo No.: 1

View of road heading South-
Cut brush in ditches & shoulder
(heavy)

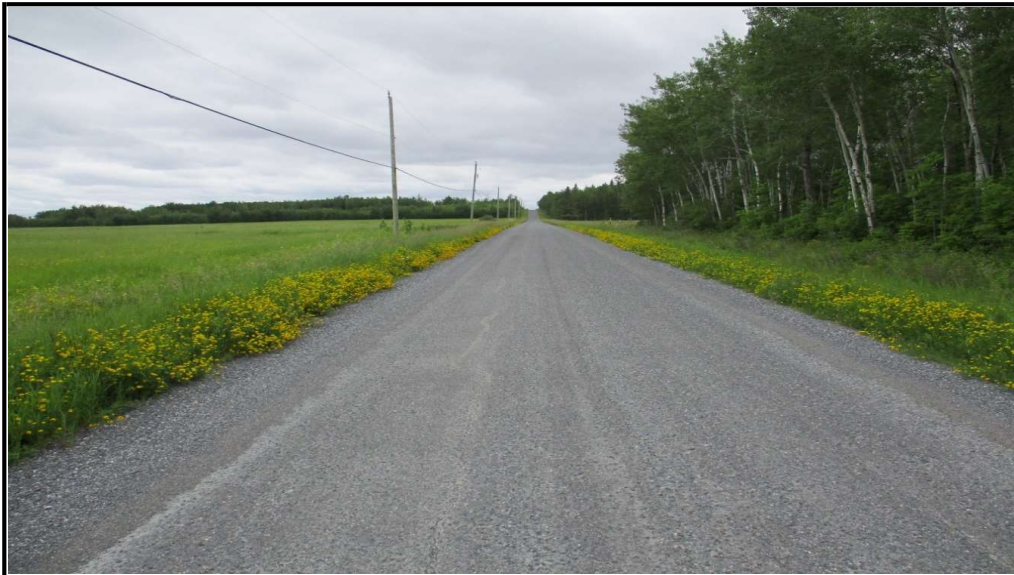
Photo No.: 1

View of road heading West-
Cut brush in ditches & shoulder
(light)

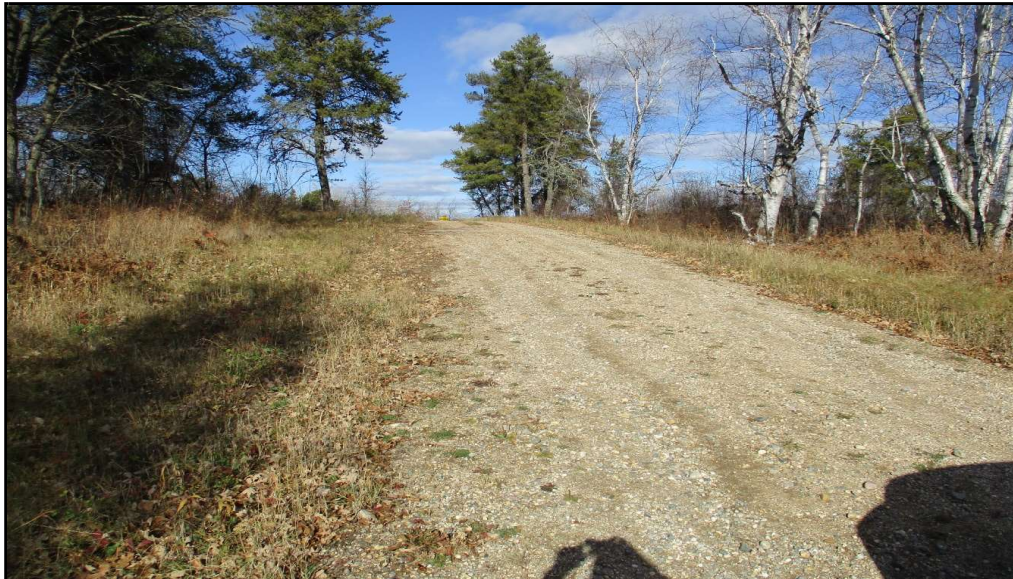
Photo No.: 1

View of road heading North
Widen road by 3.5m, Install
speed limit sign

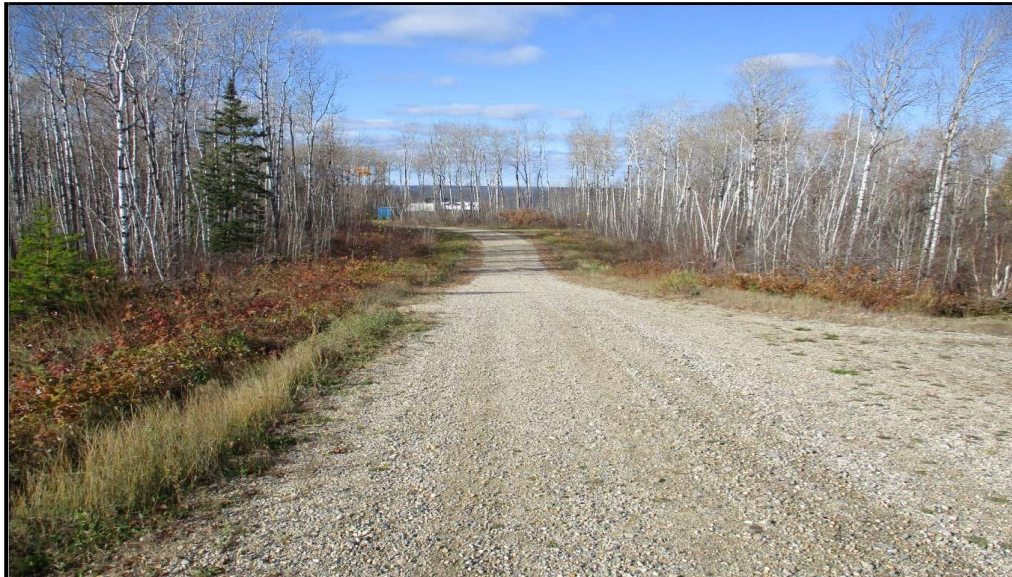
Photo No.: 1

View of road heading North-
West Widen
road by 2m,

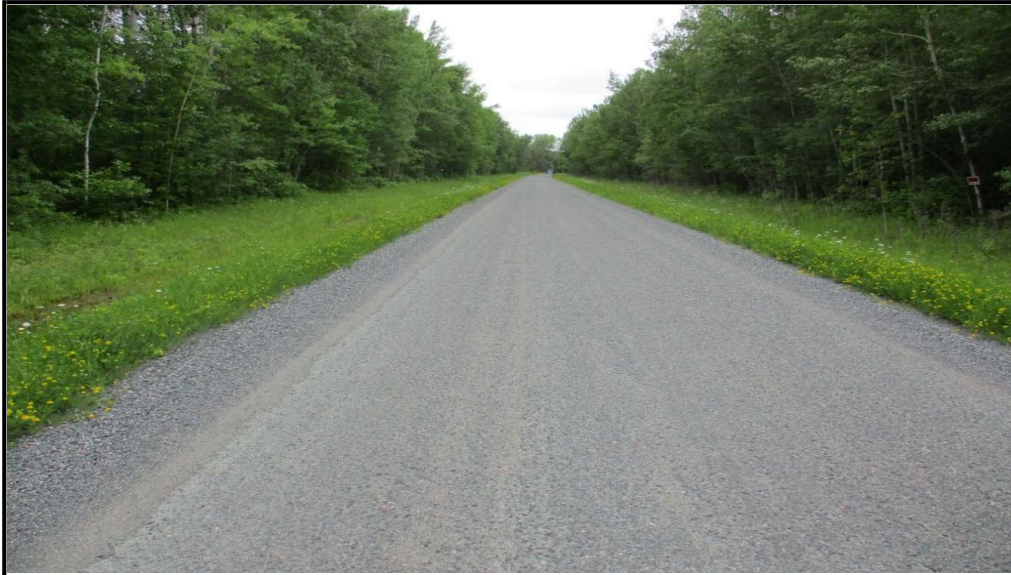
Photo No.: 1

View of road heading North-
Cut brush in ditches & shoulder
(light)

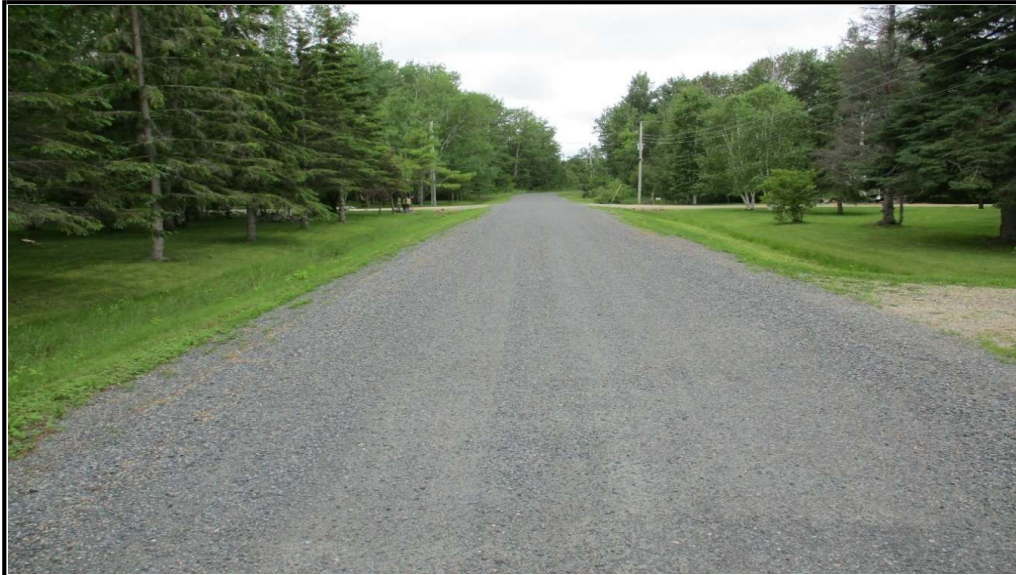
Photo No.: 1

View of road heading South-West

Cut brush in ditches & shoulder (light)

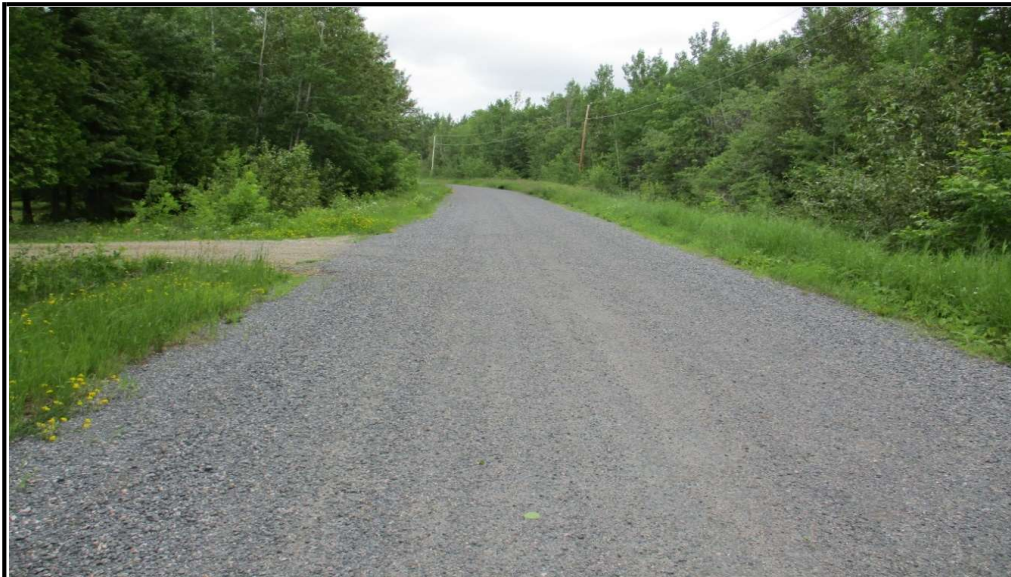
Photo No.: 1

View of road heading South-East

Cut brush in ditches & shoulder (medium)

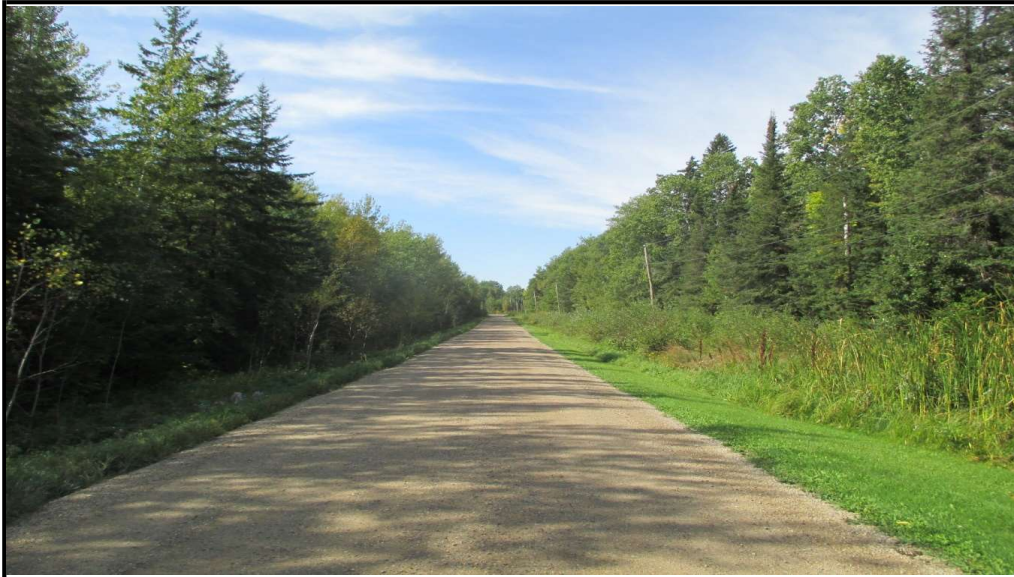
Photo No.: 1

View of road heading West-
Grade Road

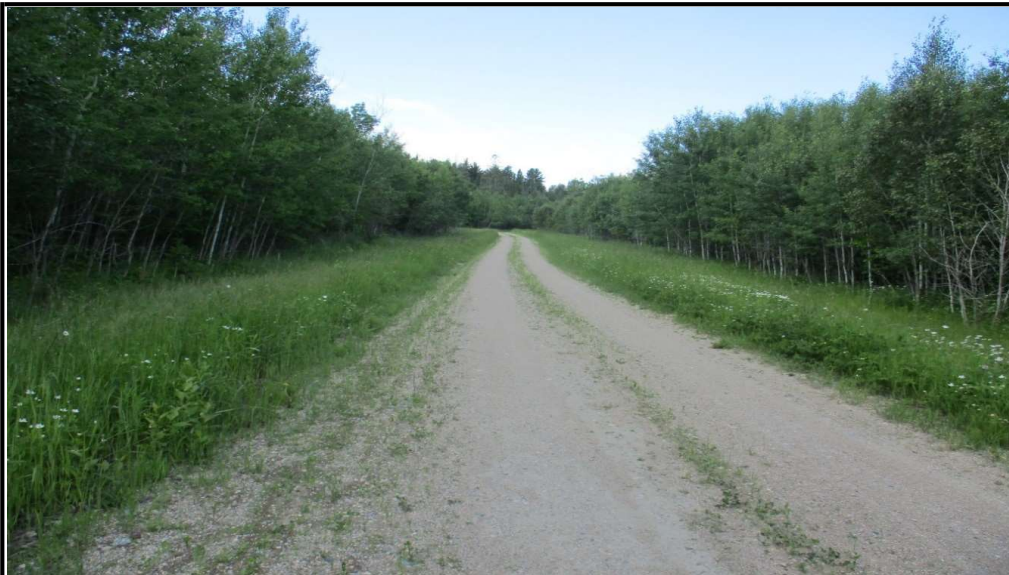
Photo No.: 1

View of road heading West-
Widen road by 1m, Cut brush in
ditches & shoulder (light)

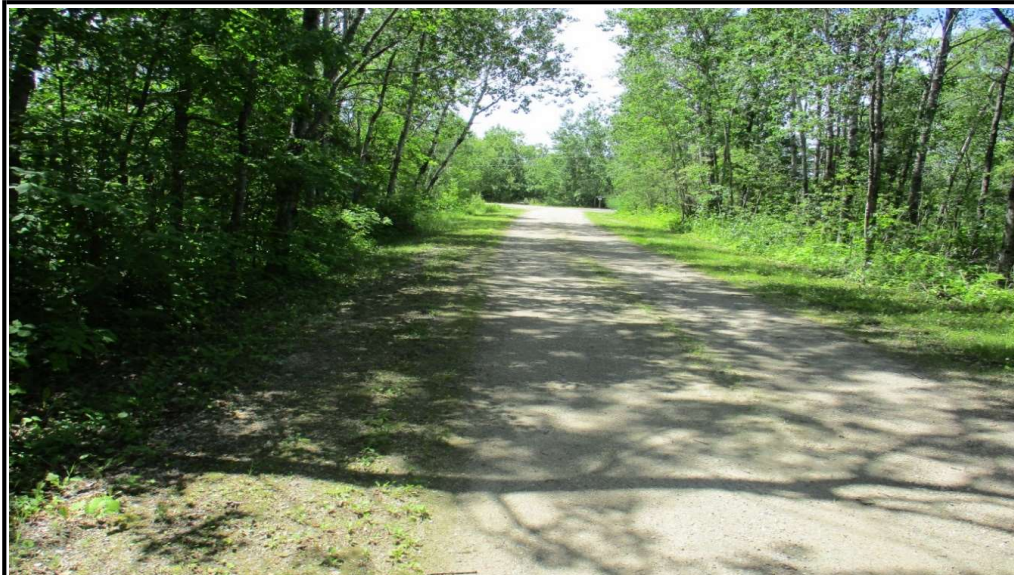
Photo No.: 1

View of road heading South-West

Widen road by 2m

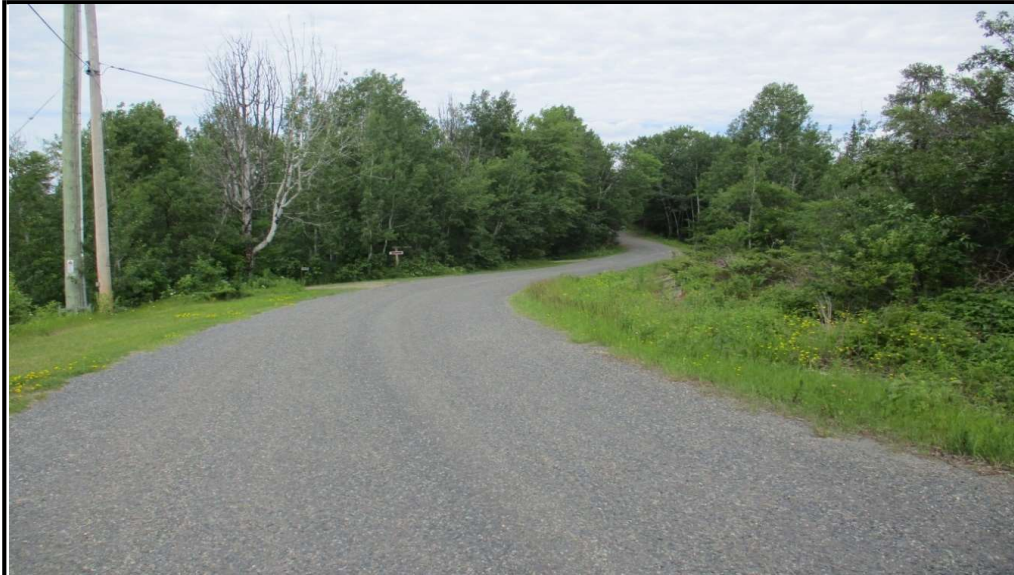
Photo No.: 1

View of road heading North-
Widen road by 0.4m, Install
speed limit signs, Install curve
signs
