2024 ASSET MANAGEMENT PLAN

Lake of the Woods
PO Box 427
Rainy River, ON, P0W 1L0

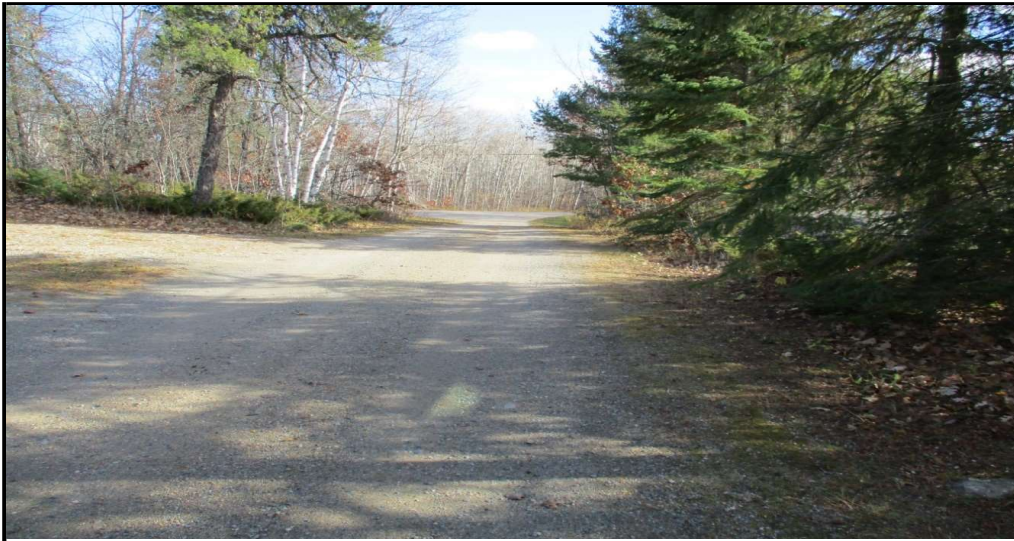
Description:
View of road heading West-
Widen road by 2m, Add 2"
gravel A

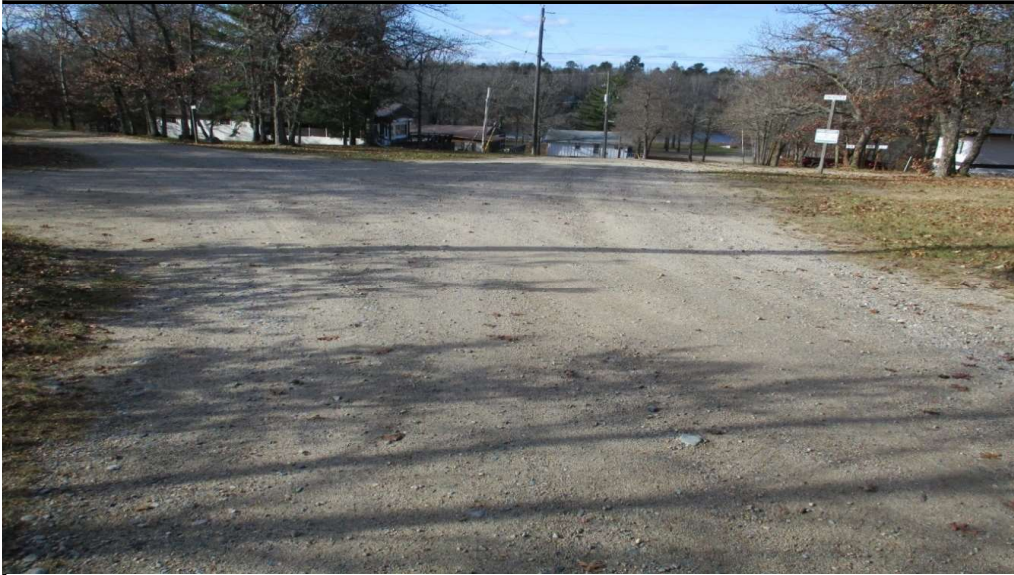
Photo No.: 2
Description:
View of road heading East-
Install street name signs

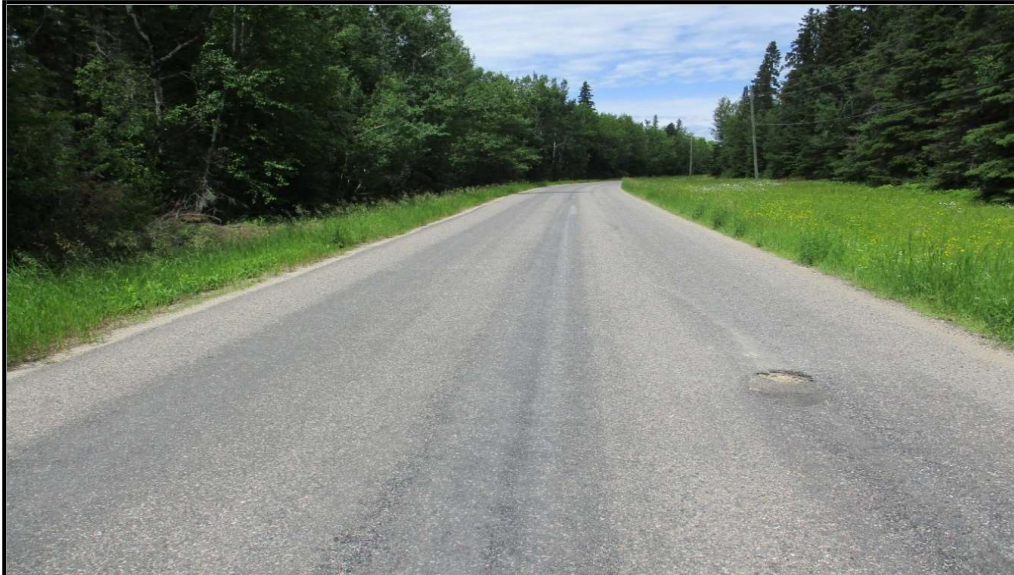
Photo No.: 1

View of road heading North-
Cut brush in ditches & shoulder
(light)

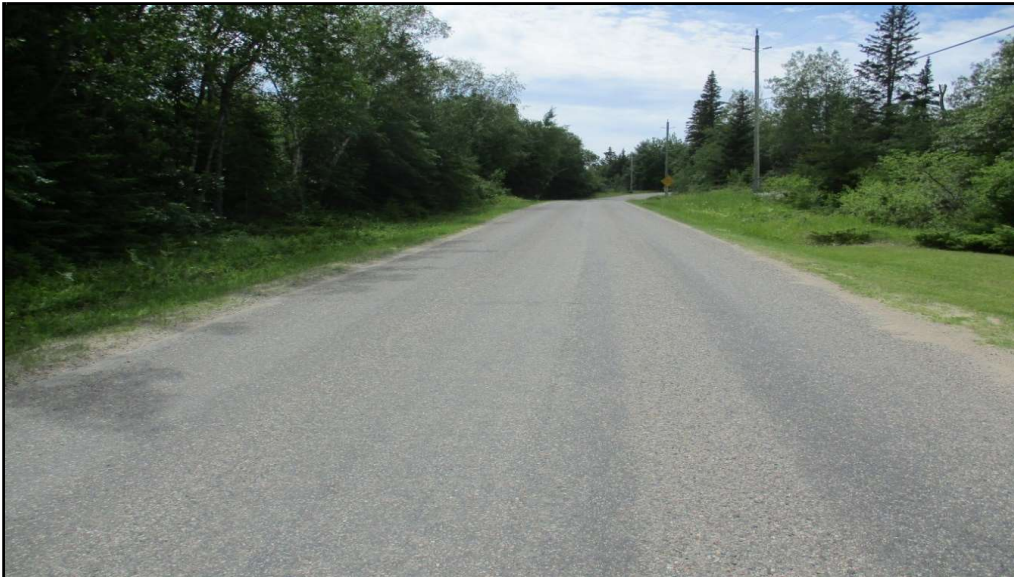
Photo No.: 1

View of road heading West-
Cut brush in ditches & shoulder
(light)

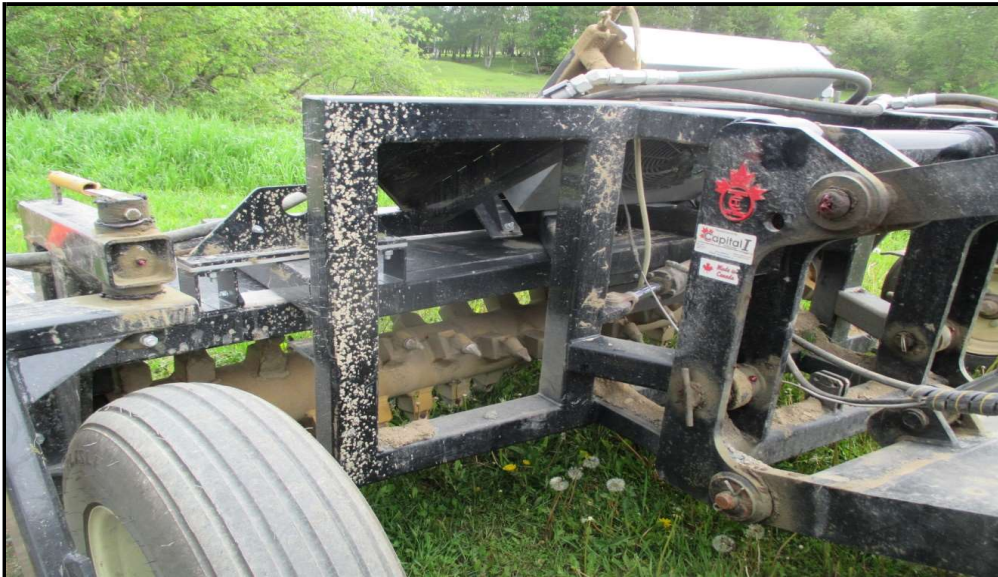
Photo No.:
 Description:
 The view of the Mulcher

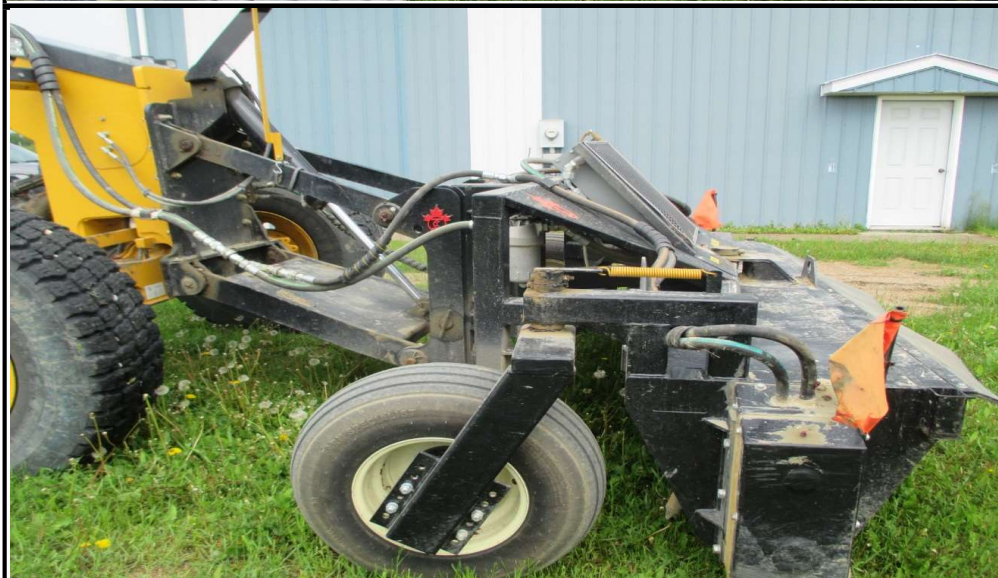
Photo No.:
 Description:
 The view of the Mulcher

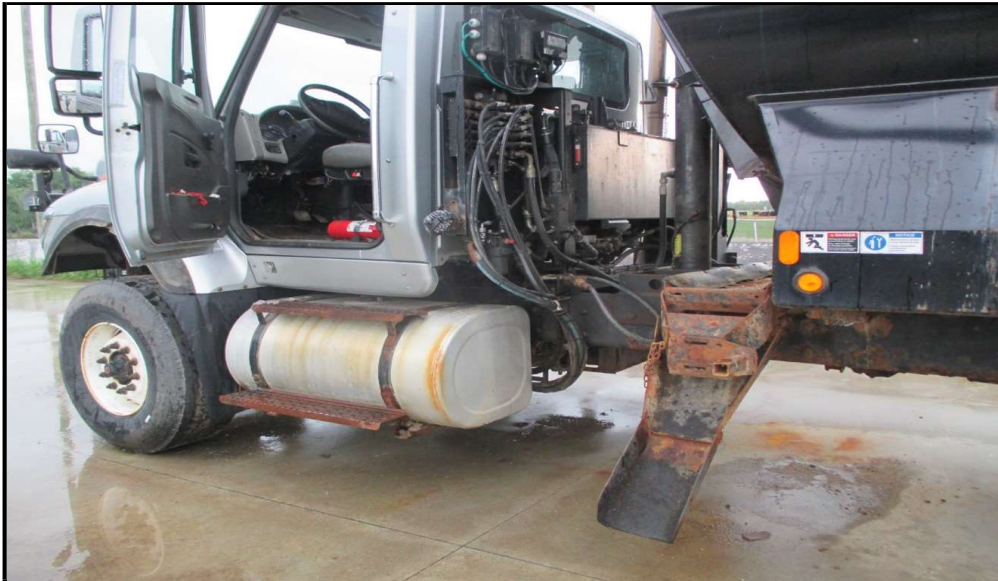
Asset / Component Code No.	Description of Needs	G r p (*1)	C a t (*2)	T y p (*3)	U r g (*4)	Amount (\$)	Needs No.
2.11	Repaint rusting side steps and fuel tank	1	1	3	1	\$ 1,500.00	
Total						\$ 1,500.00

Exterior view
Repaint rusting side steps and
fuel tank

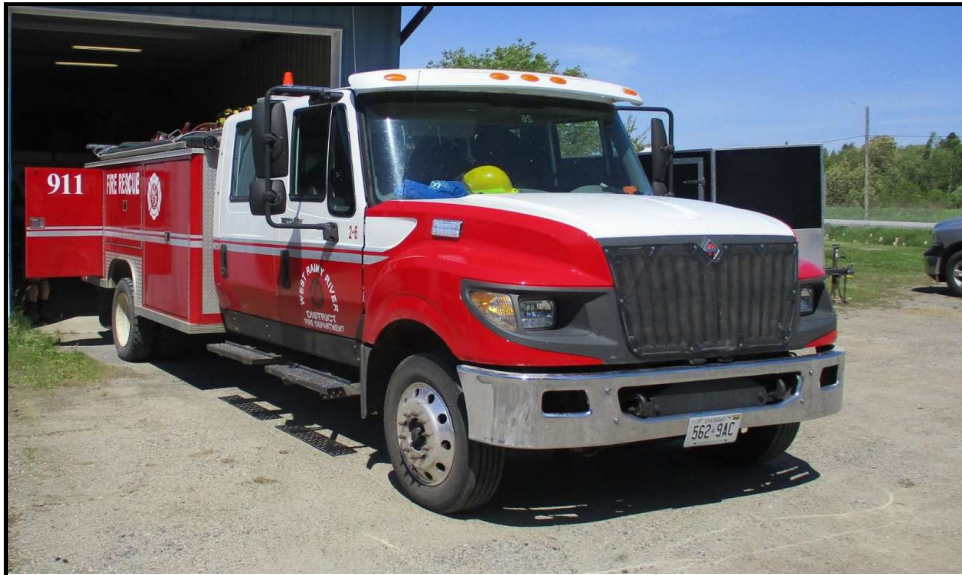
Photo No.: 1
 Description:
 Exterior view

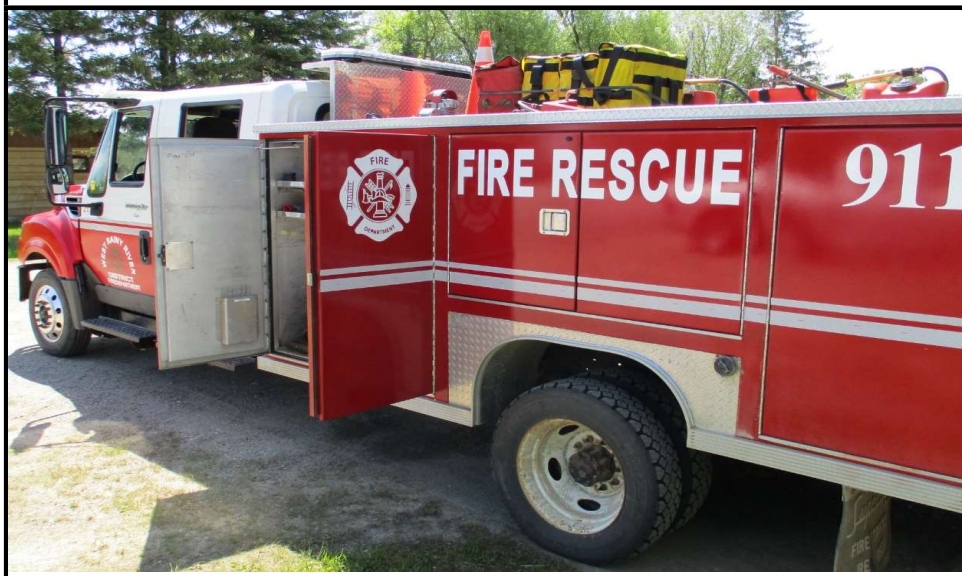
Photo No.: 2
 Description:
 Exterior view

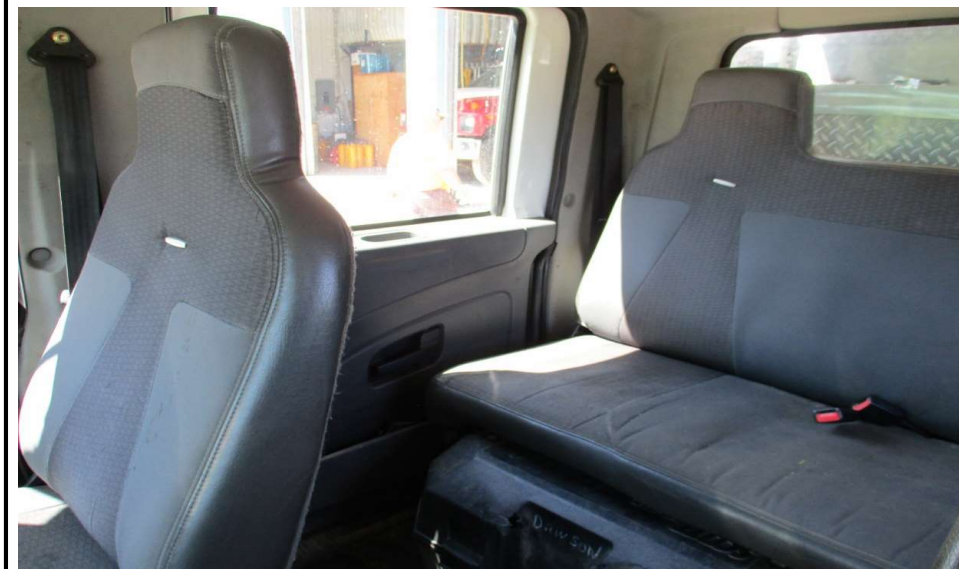
Photo No.: 3

Description:
Interior view

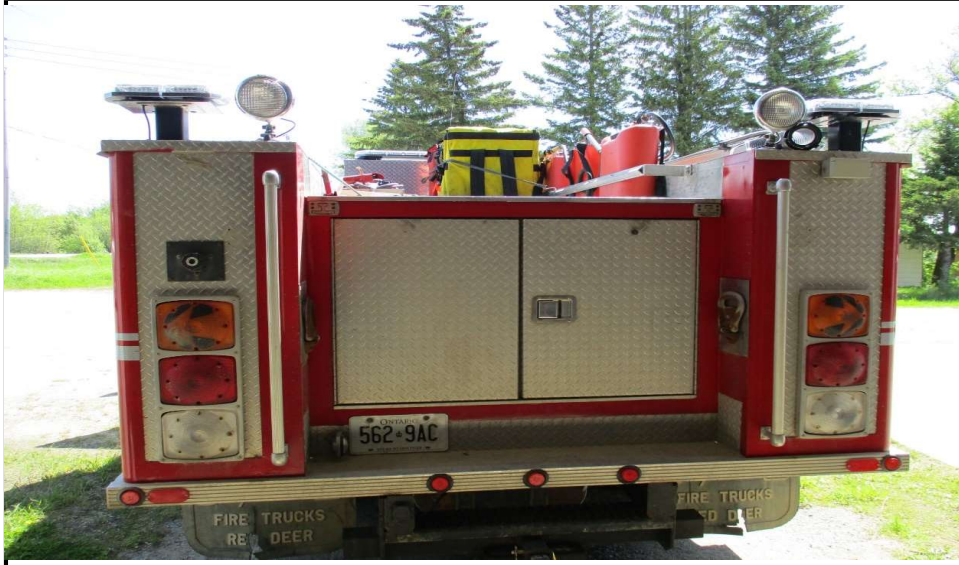
Photo No.: 4

Description:
Exterior view
